Prepared for:

Cooperstown Partners, LLC.
Attn: Jim Adams
836 East 64th Street
Indianapolis, IN 46220

Submitted to:
Hamilton County Drainage Board
Attn: Kenton C. Ward
One Hamilton County Square, Suite 188
Noblesville, IN 46060

February 26, 2014

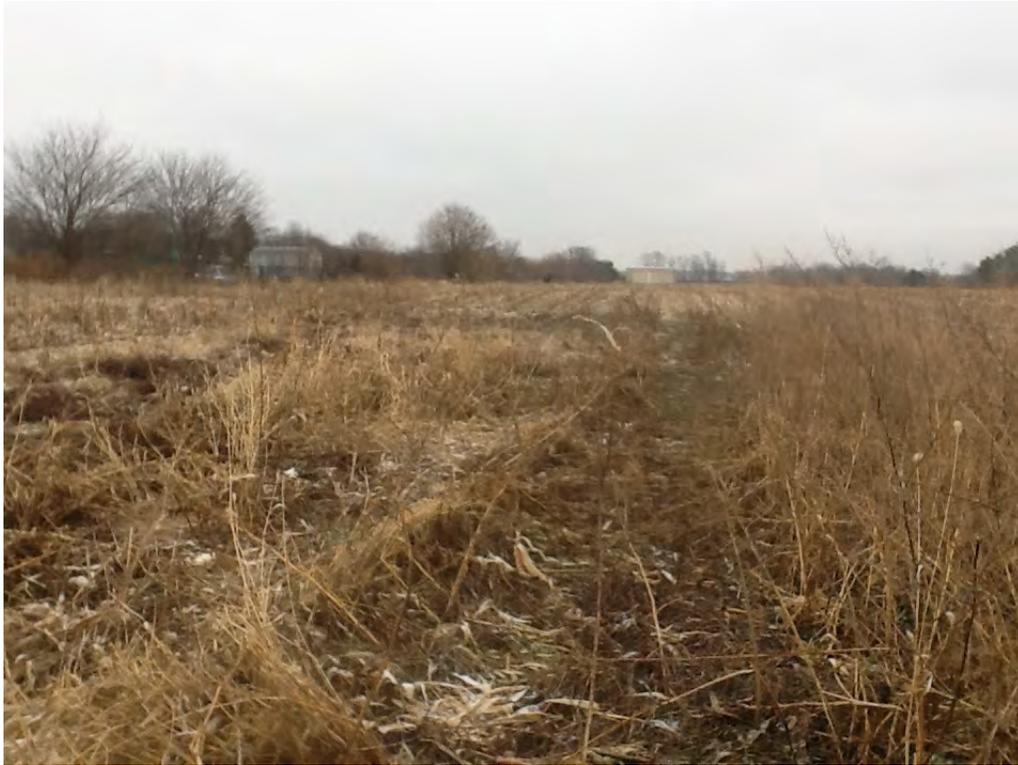
Photo #1 – Looking northeast from upper end of drain “along alignment”.

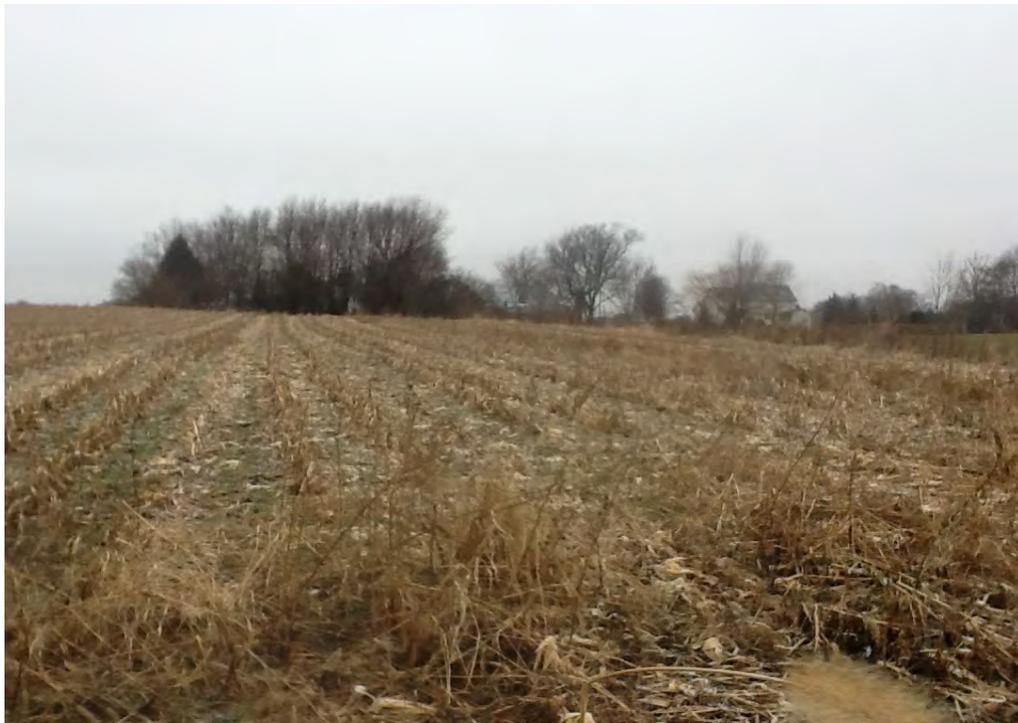
Photo #2 – Looking west from upper end of drain “unregulated”.

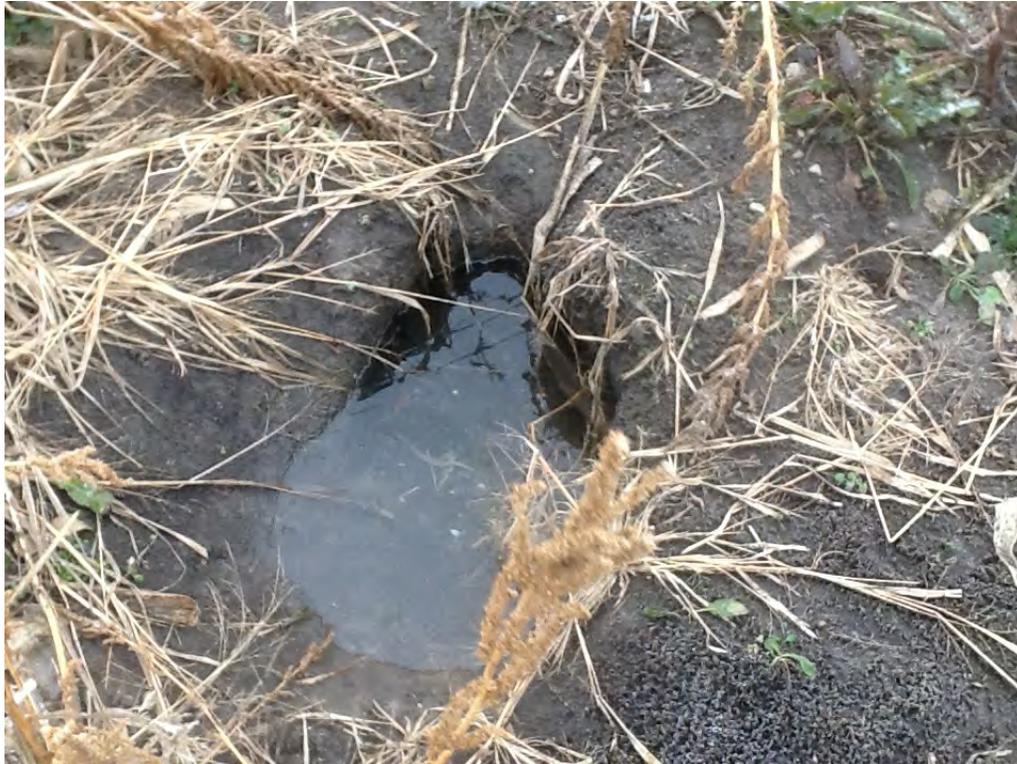
Photo #3 – Private tile hole 240' +/- from regulated drain.

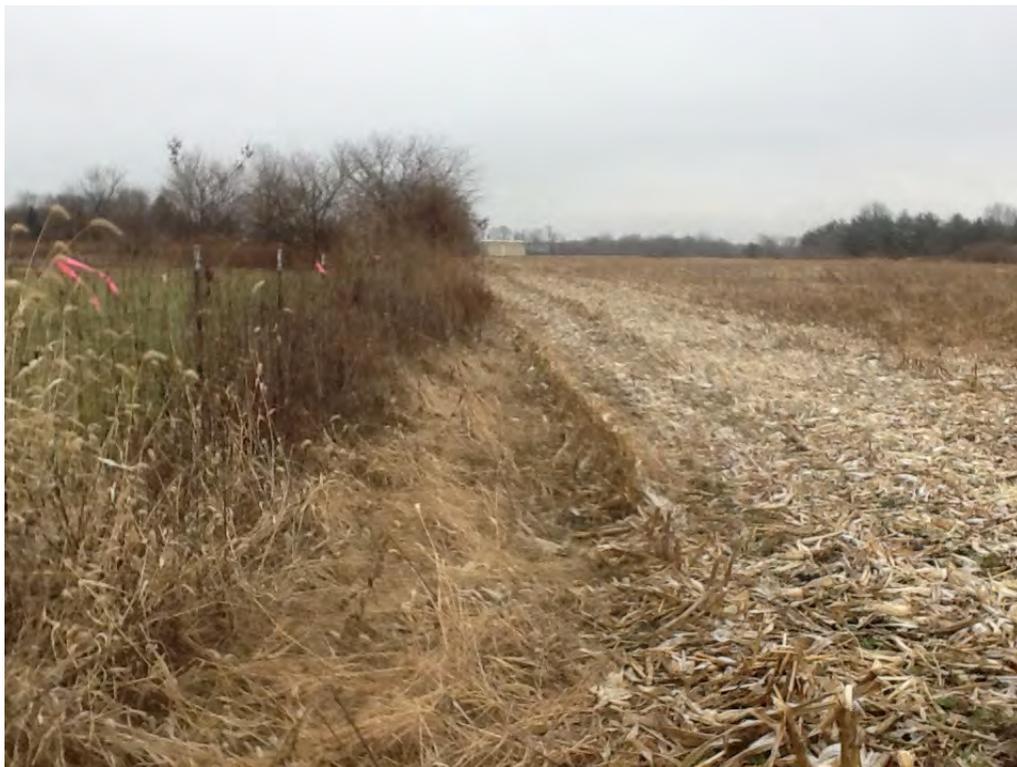
Photo #4 – Looking east from eastern property line of proposed development.

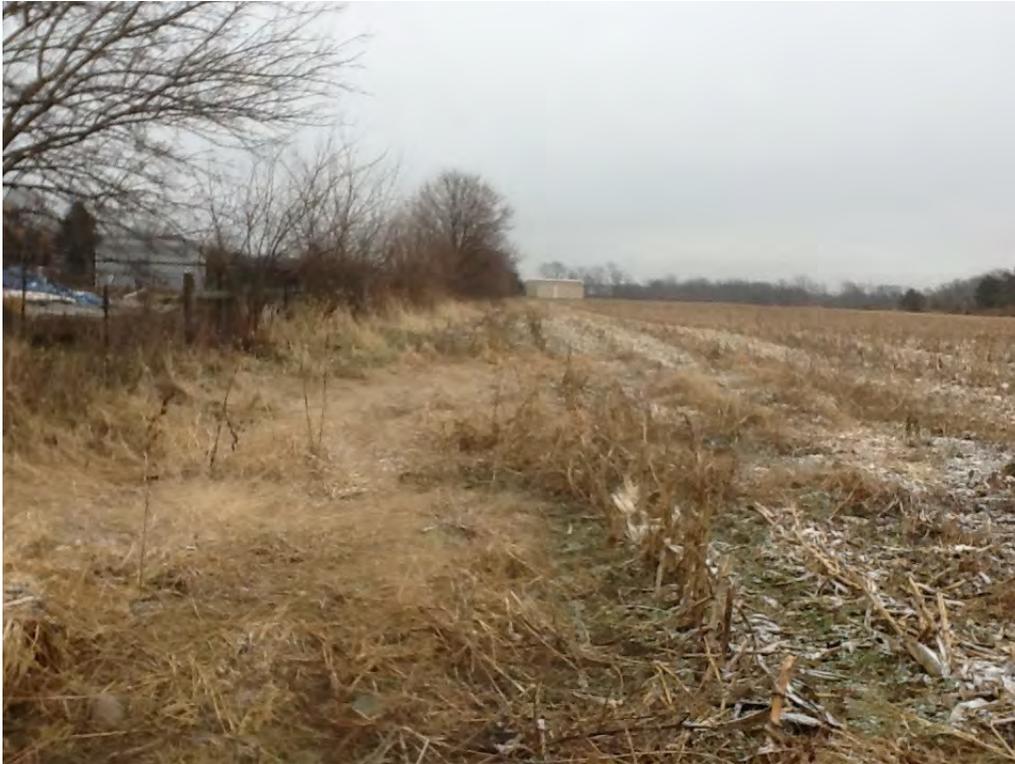
Photo #5 – Looking east from future structure #109.

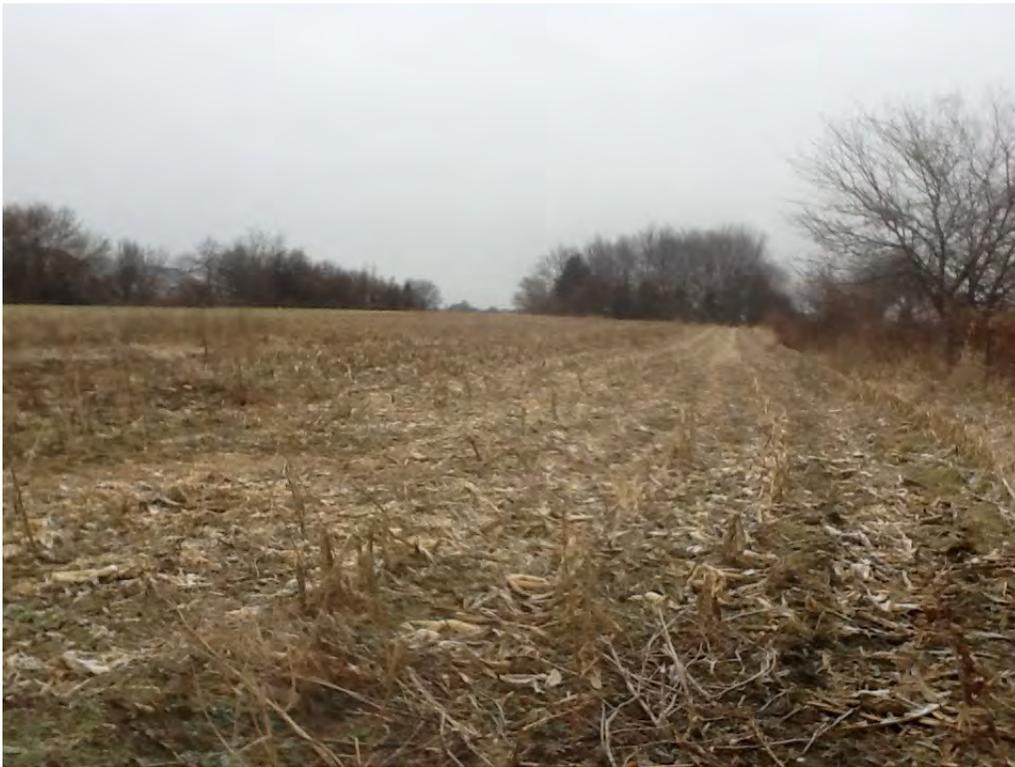
Photo #6 – From south of Sandlin property looking west.

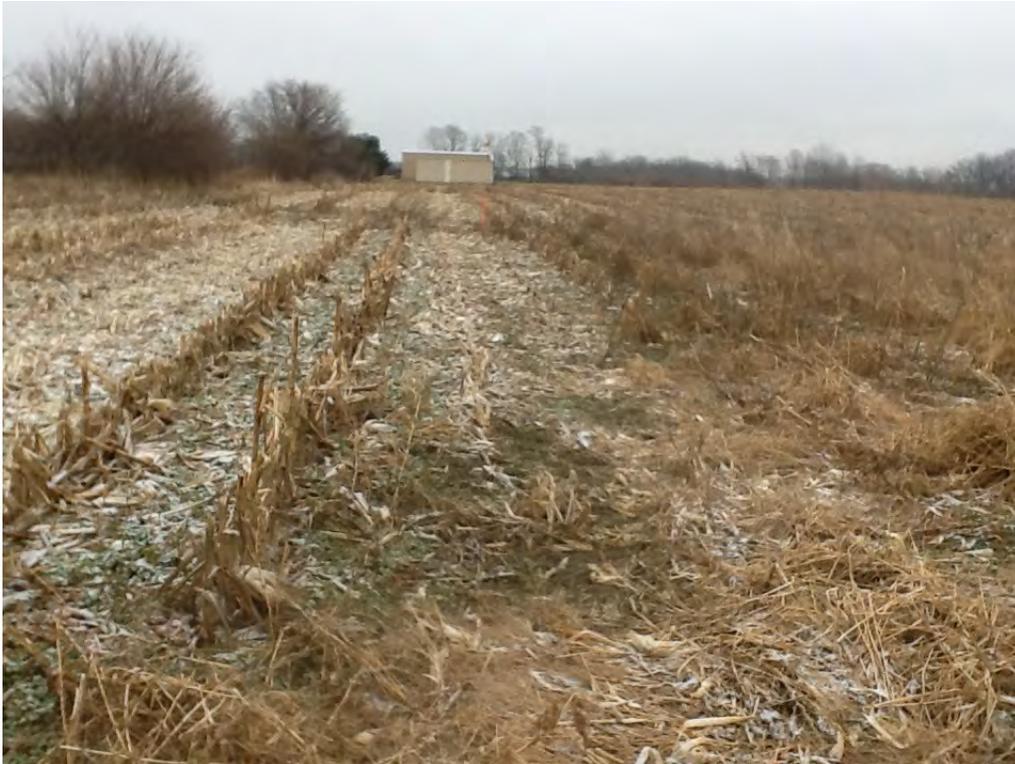
Photo #7 – “Same as above” looking east.

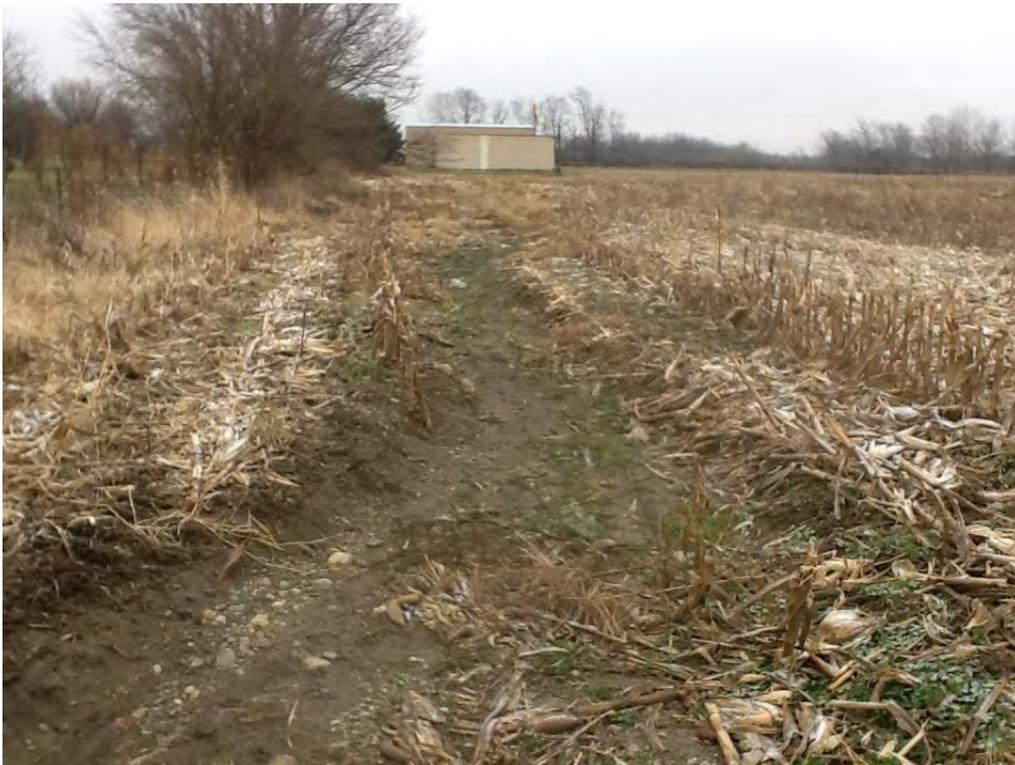
Photo #8 – Surface water erosion due to broken down tile / lack of capacity.

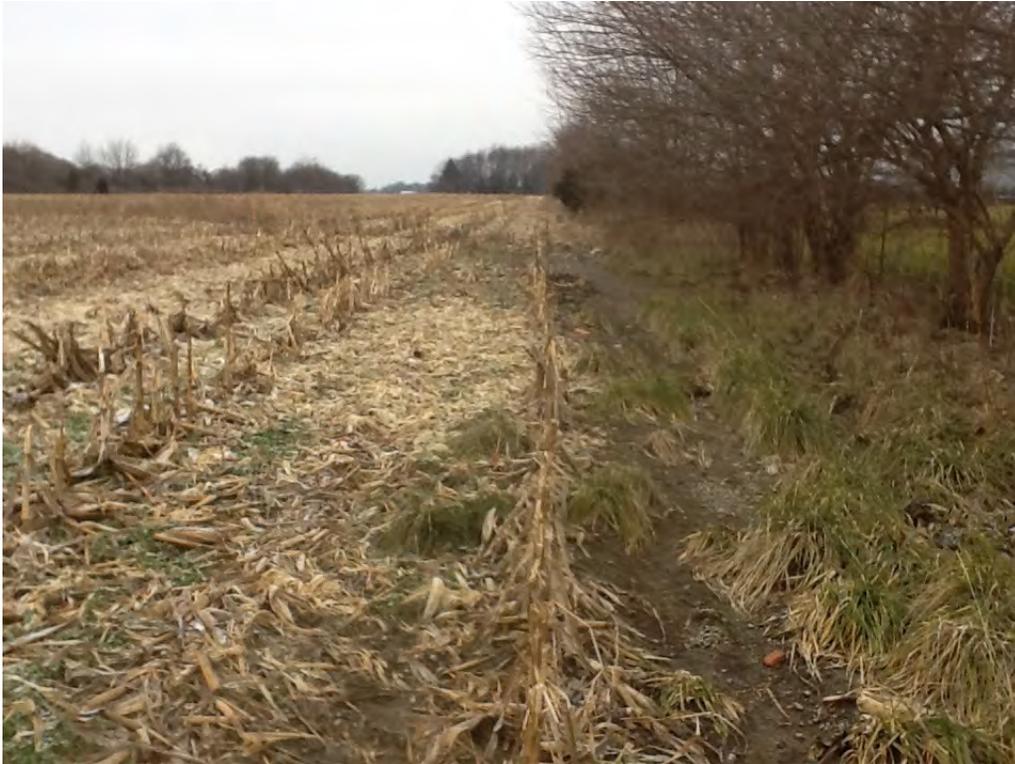
Photo #9 – From south side of Wiegand property looking west more erosion.

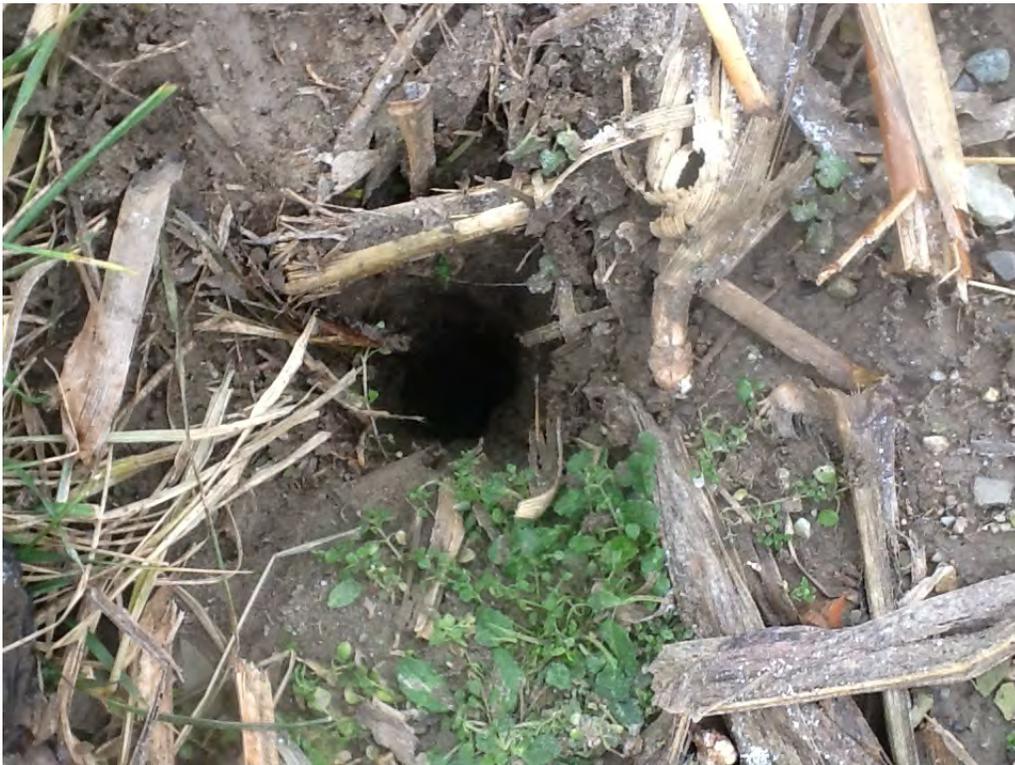
Photo #10 – Tile blow hole.

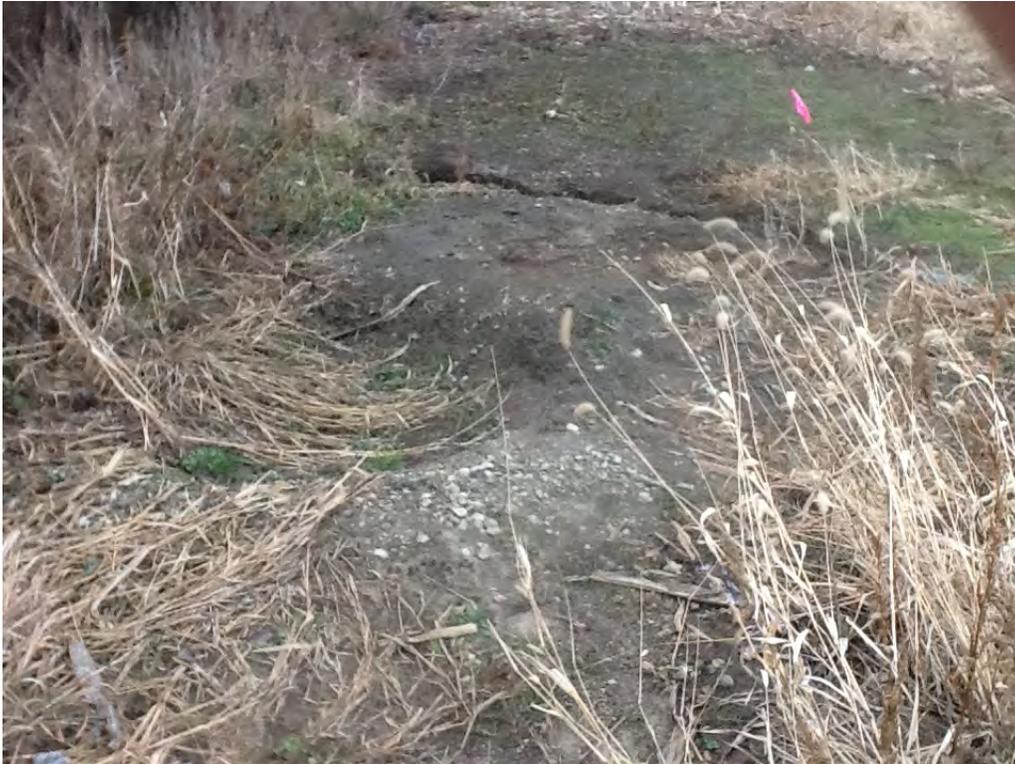
Photo #11 – Start of tile blow hole and surface erosion.

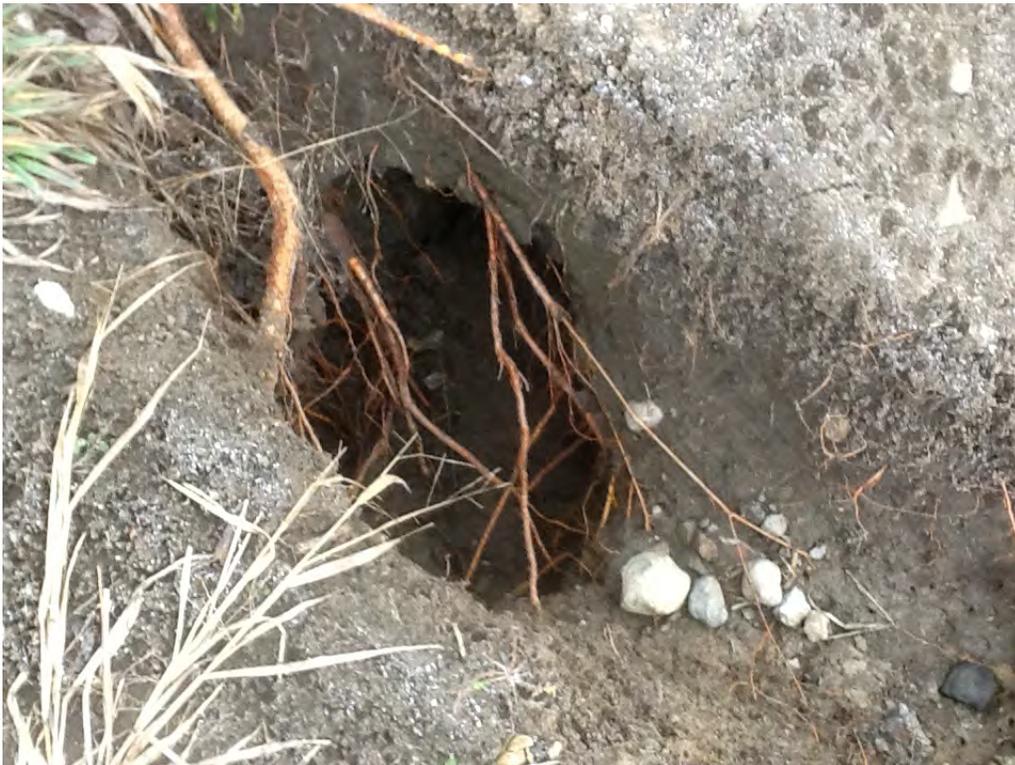
Photo #12 – Root infiltration into tile and blow hole just south of Marcum property.

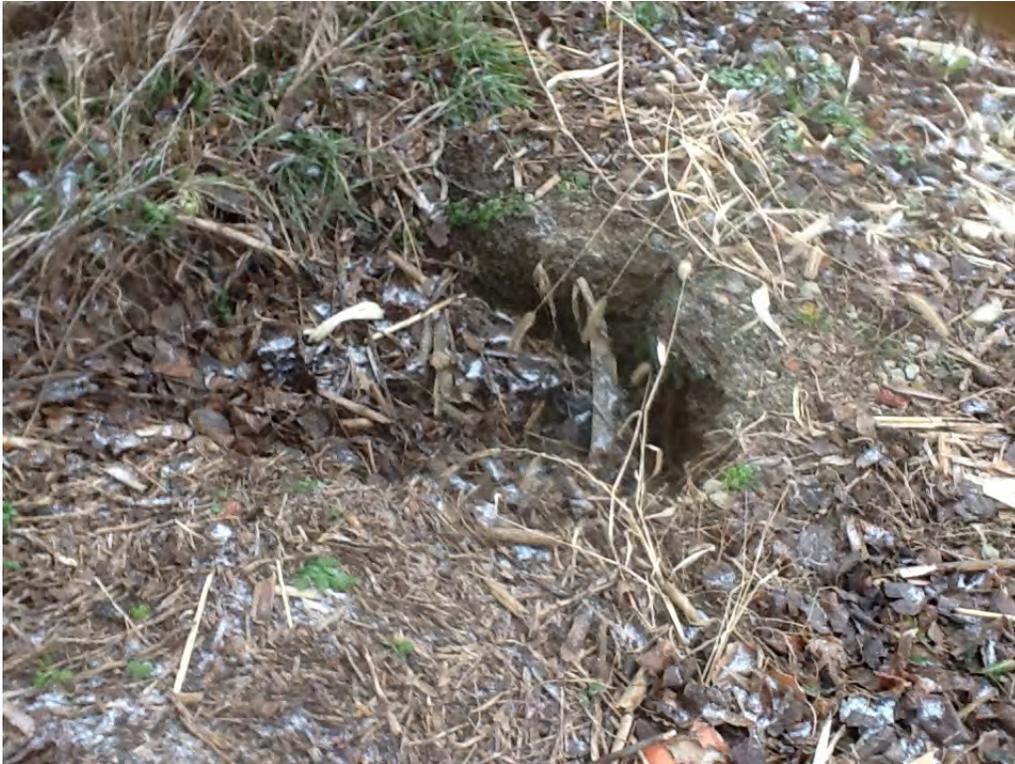
Photo #13 – Another start of a blow hole south of Marcum property.

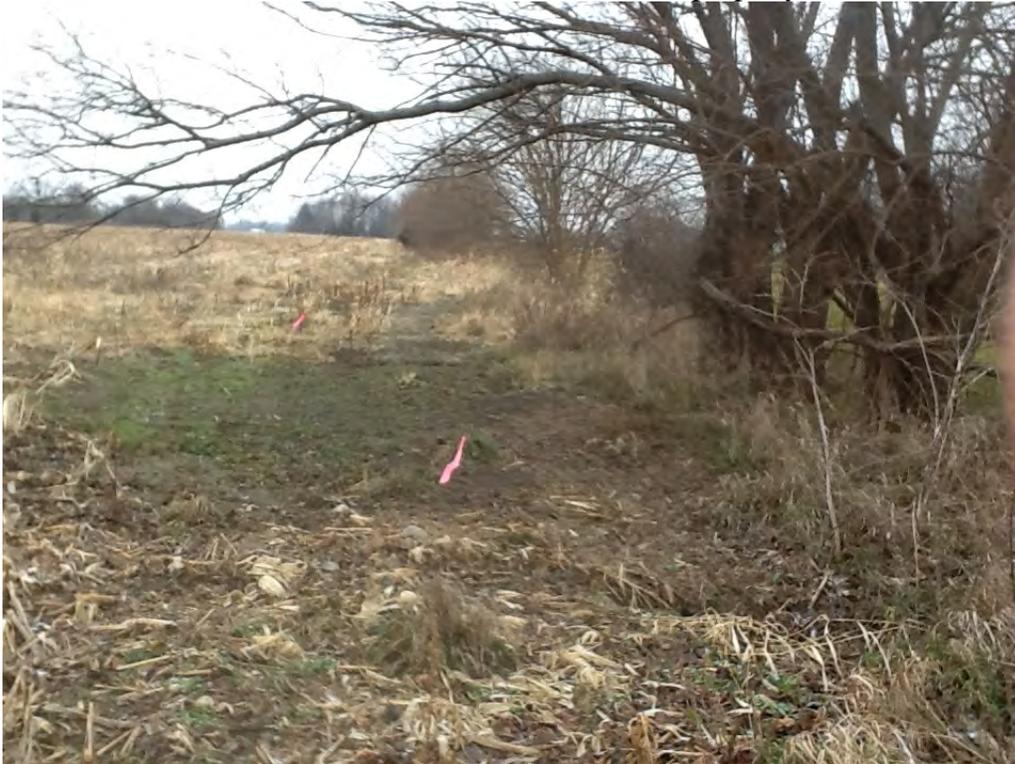
Photo #14 – From south of Marcum property looking west.

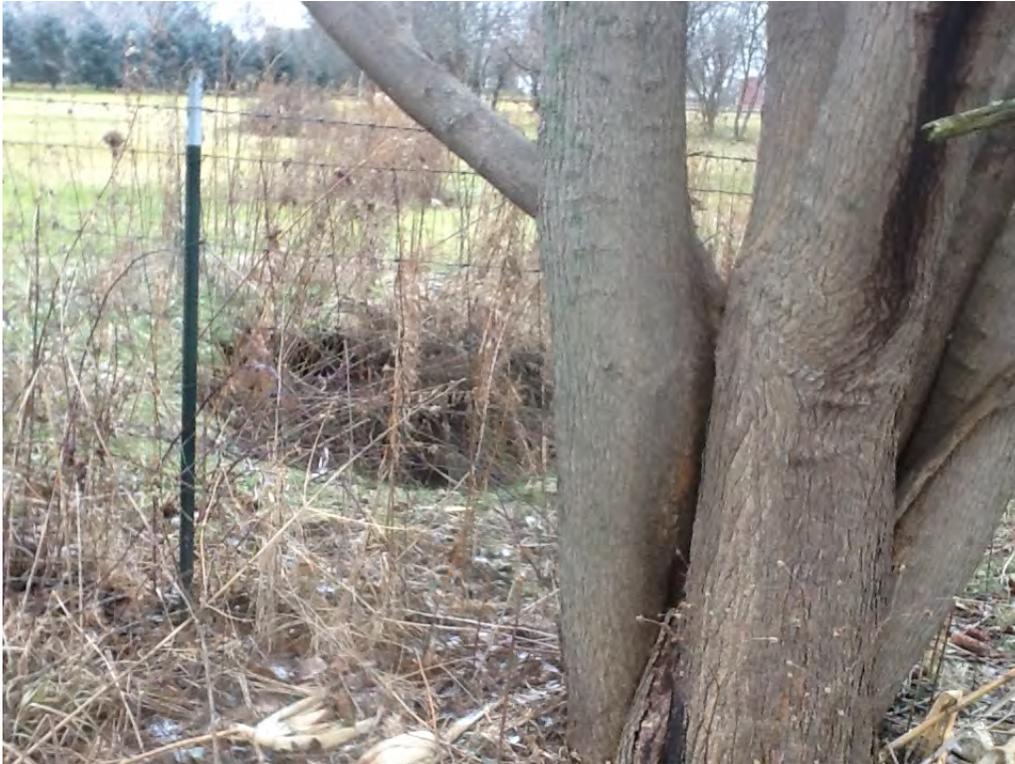
Photo #15 – Looking north onto Marcum property at (3) large blow holes on mutual drain.

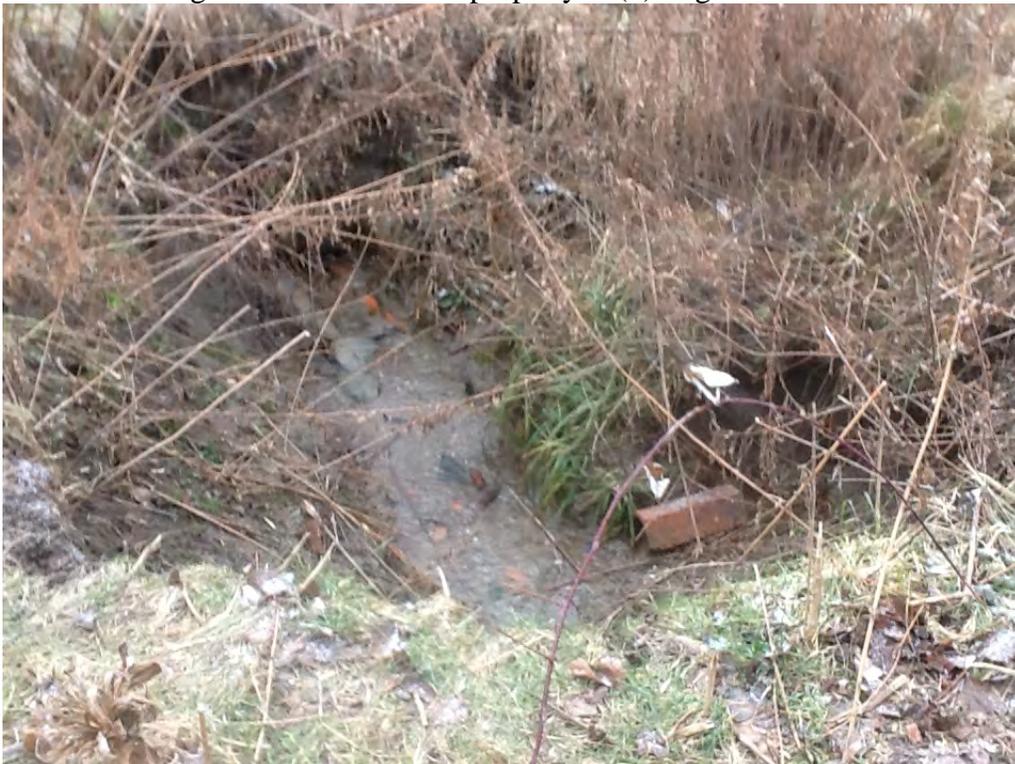
Photo #16 – Large blow hole on Marcum property mutual drain.

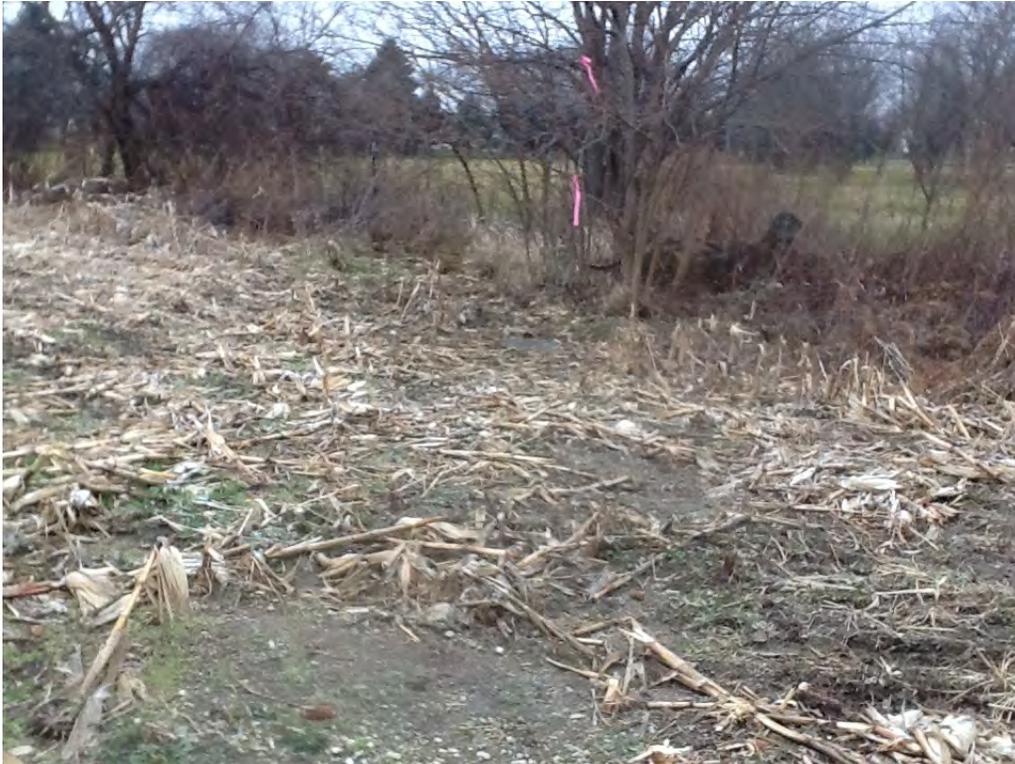
Photo #17 – Looking north to future structure 112.

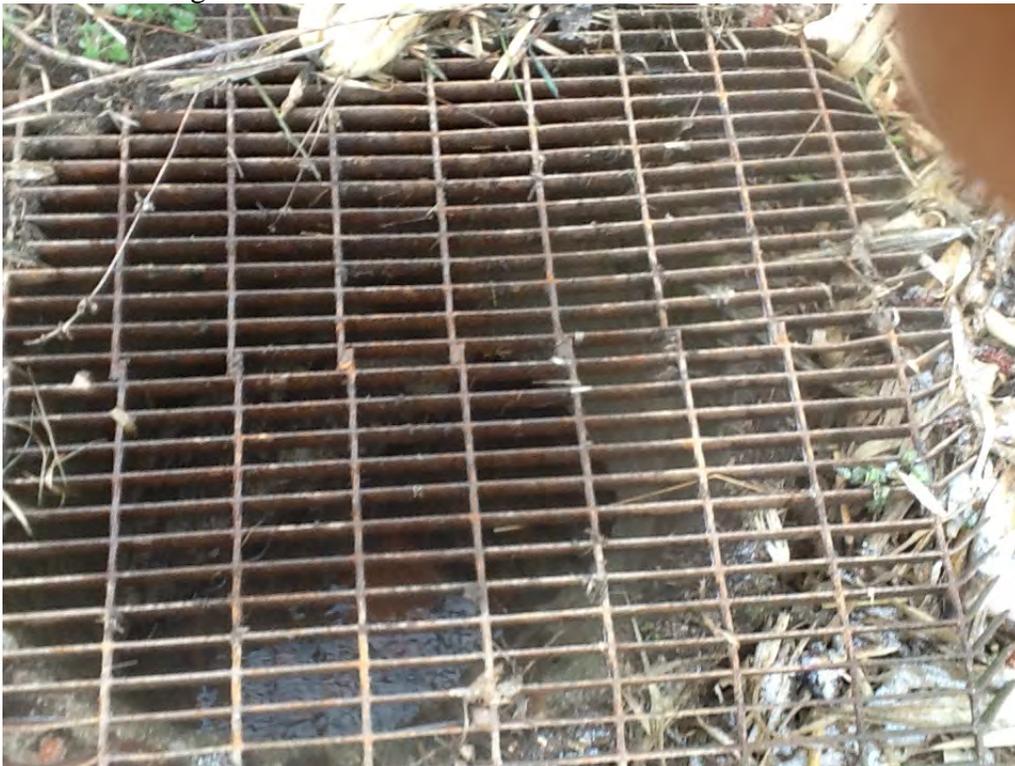
Photo #18 – Looking at structure to be replaced with structure 112.

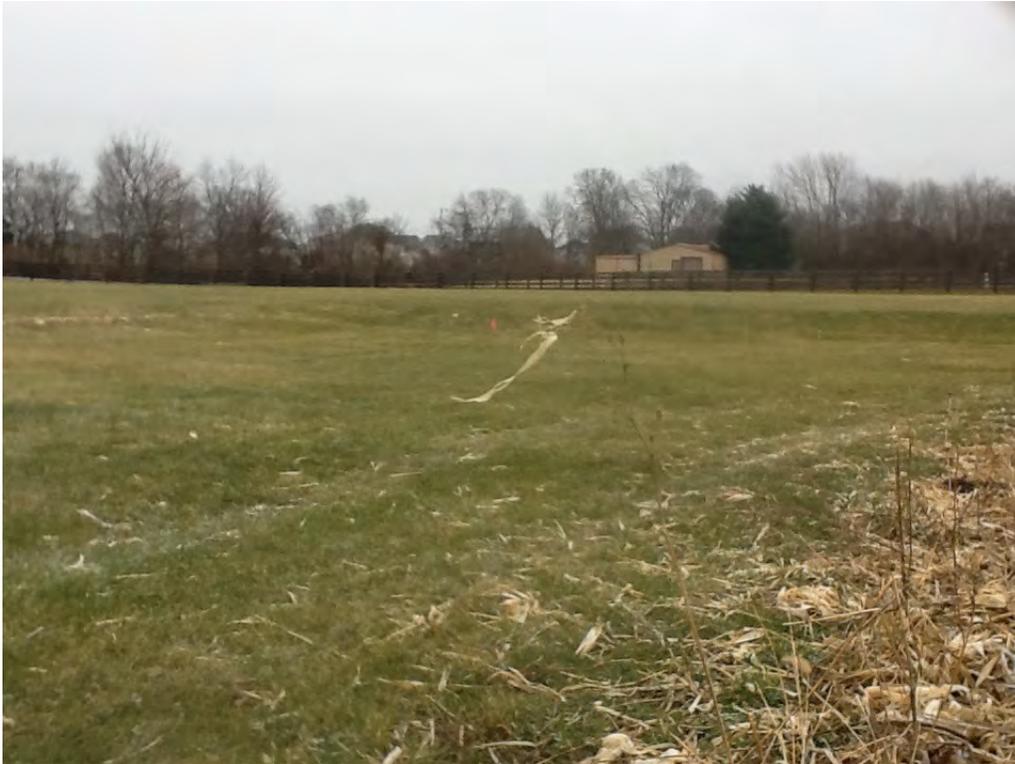
Photo #19 – Looking south to grass airstrip along drain line; notice flood debris line.

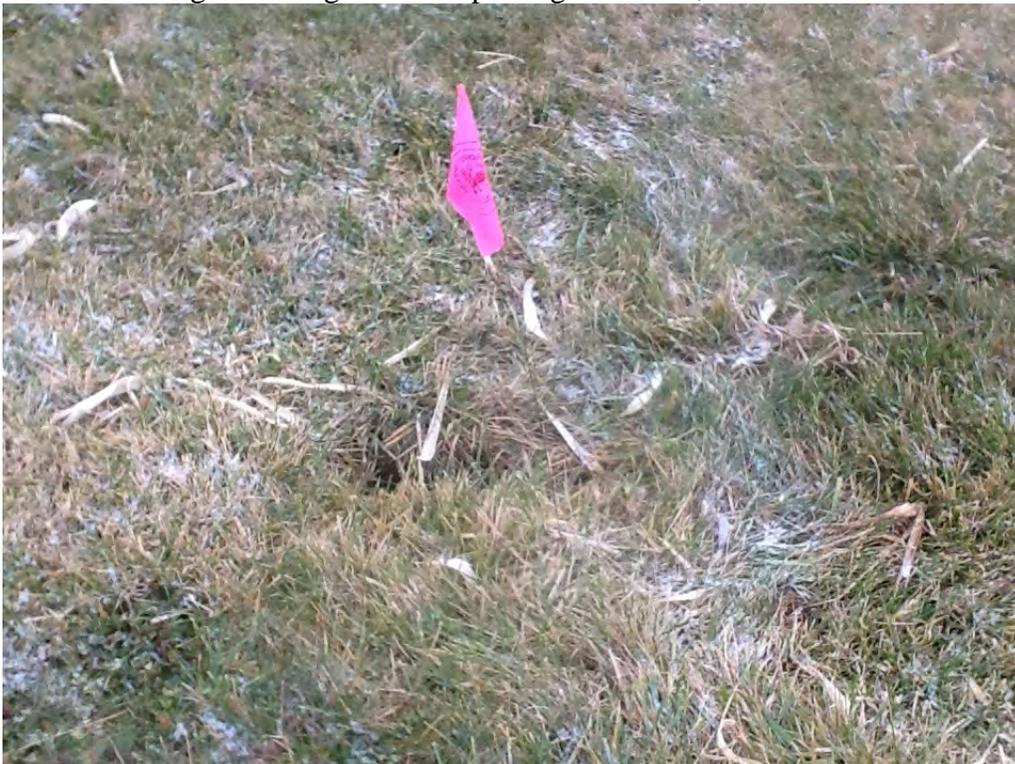
Photo #20 – Marked blow hole just north of grass airstrip.

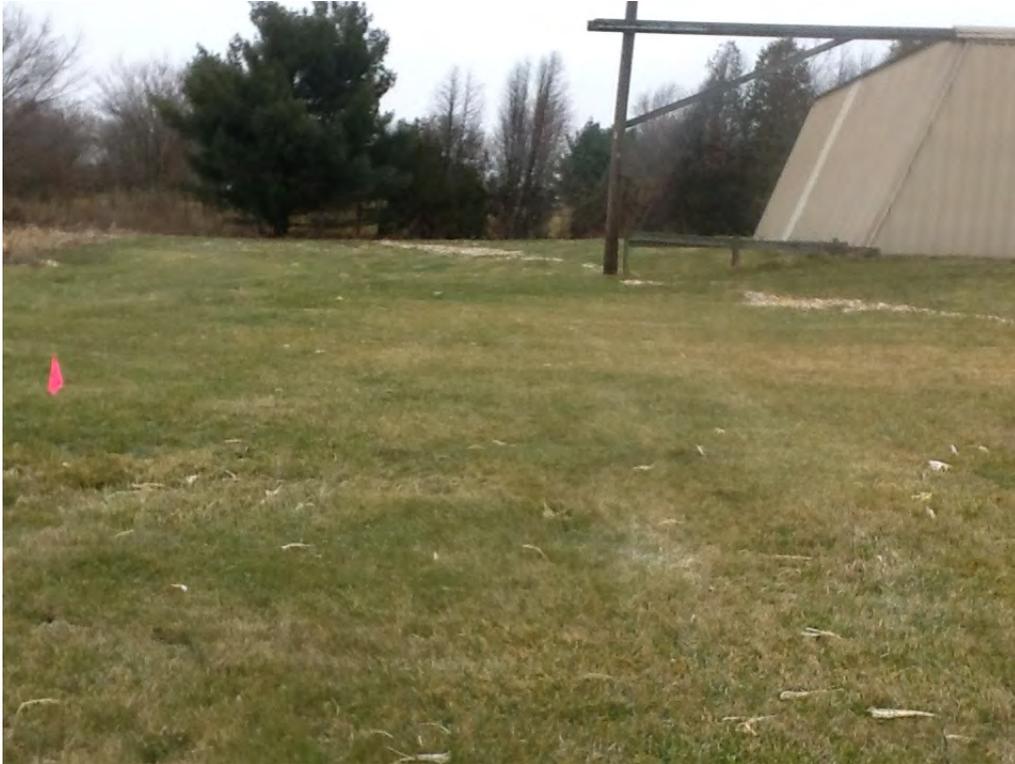
Photo #21 – Looking north from airstrip; notice flood debris line.

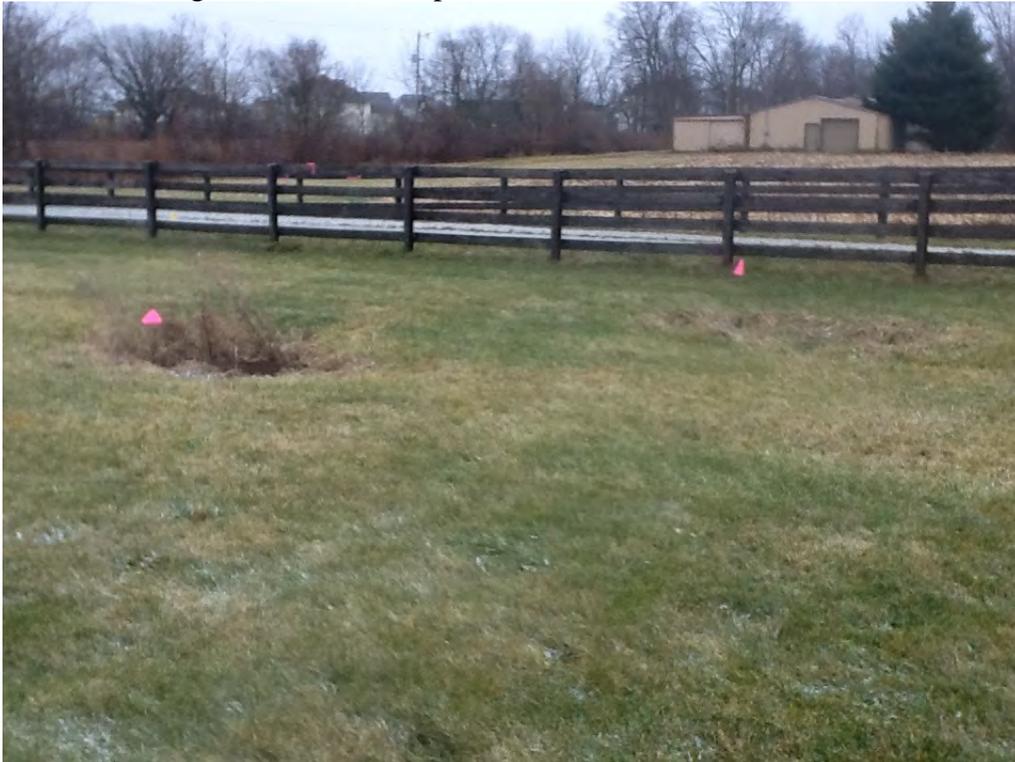
Photo #22 – Looking south from airstrip. (2) more blow holes.

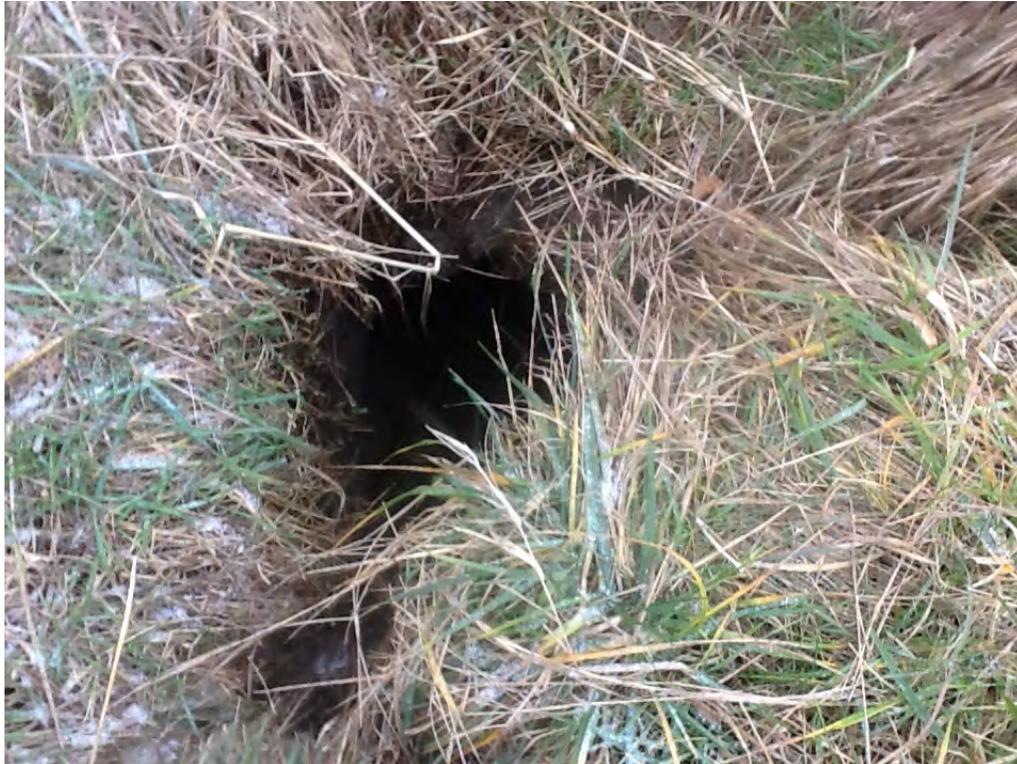
Photo #23 – Upclose shot of blow hole south of airstrip.

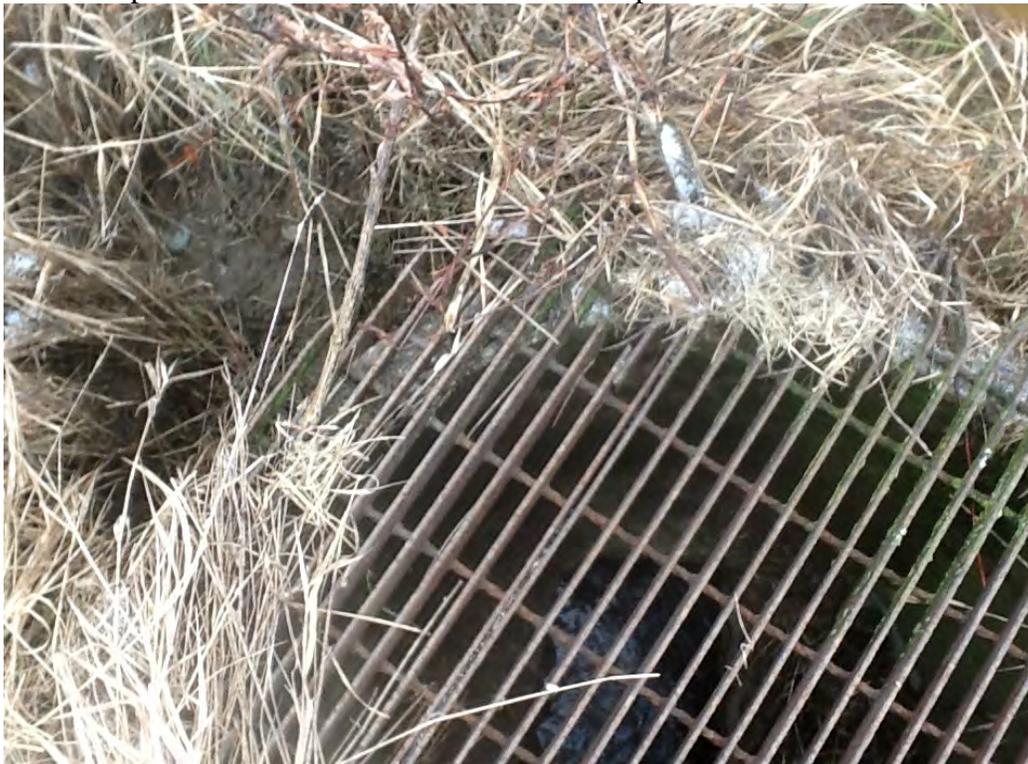
Photo #24 – Structure to be replaced with structure #103; notice infiltration on side.

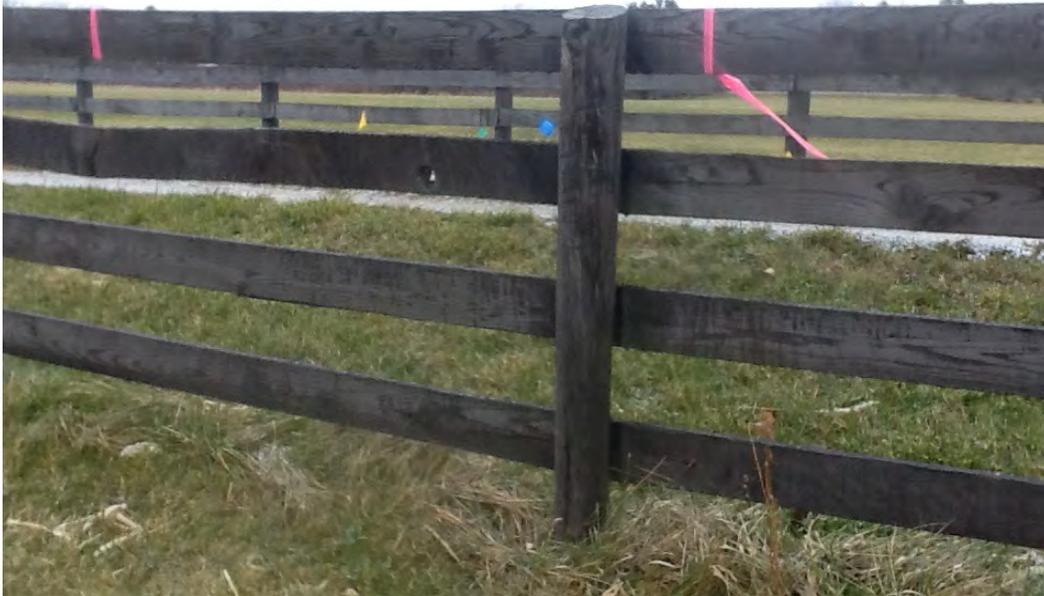
Photo #25 – Wooden fence between structures 103 & 102, gravel drive.

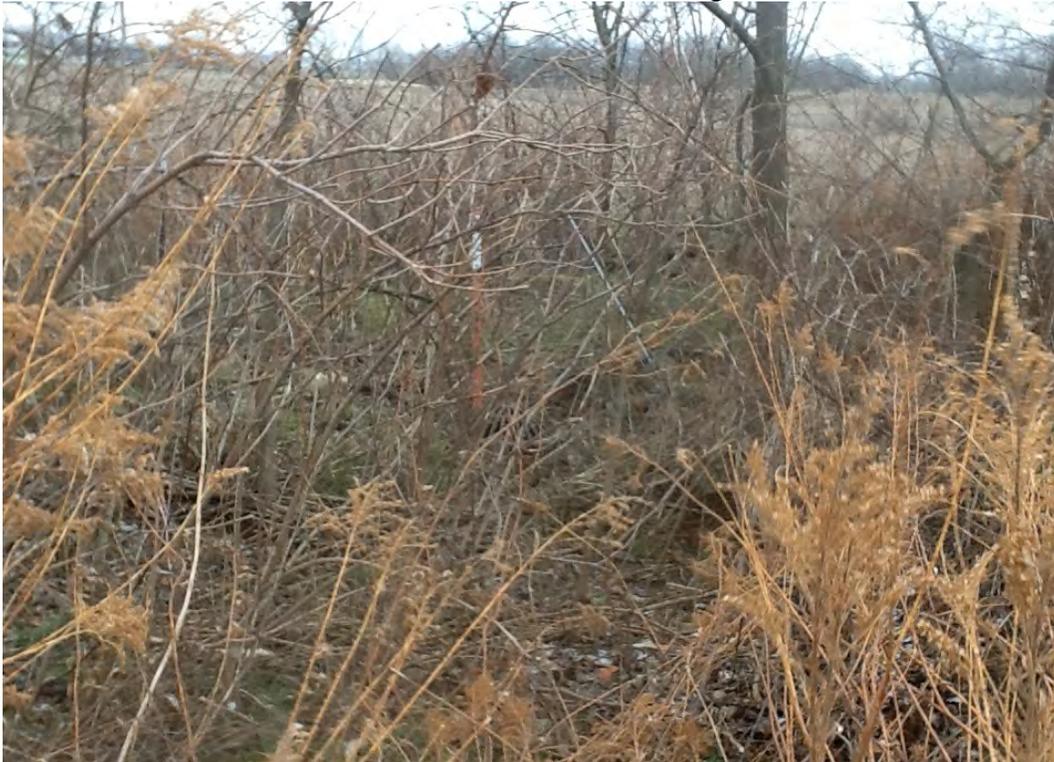
Photo #26 – Drain marker and inlet along Ferraro/Heritage Baptist Church property line.

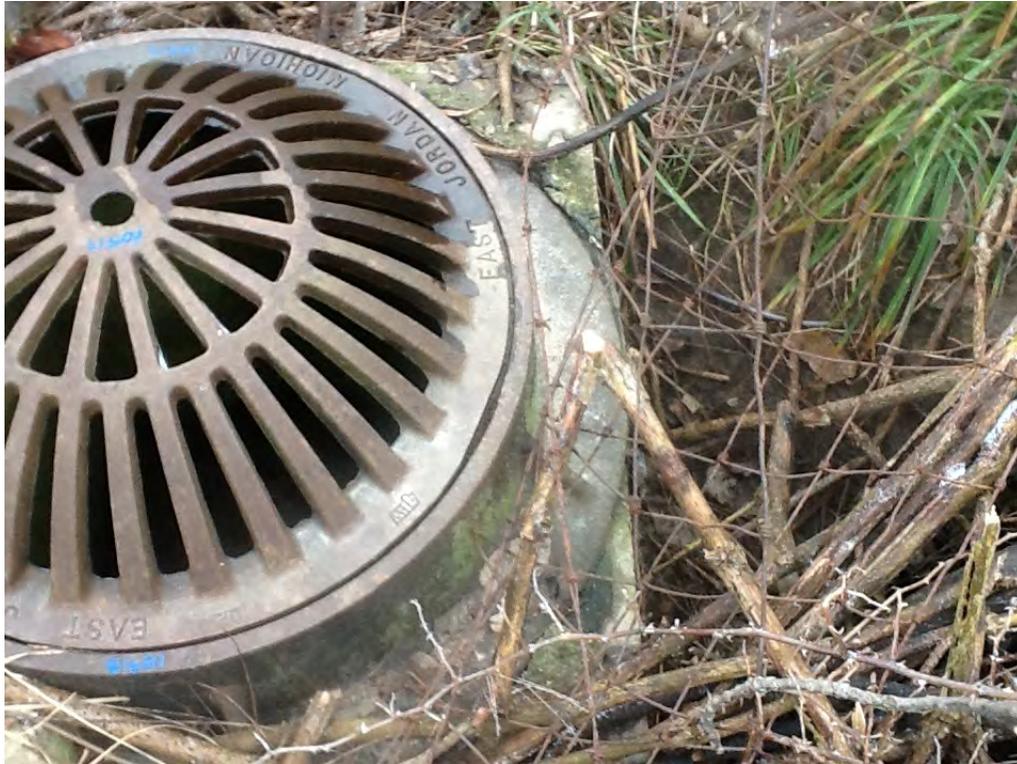
Photo #27 – Structure to be replaced with structure 101; notice side infiltration.

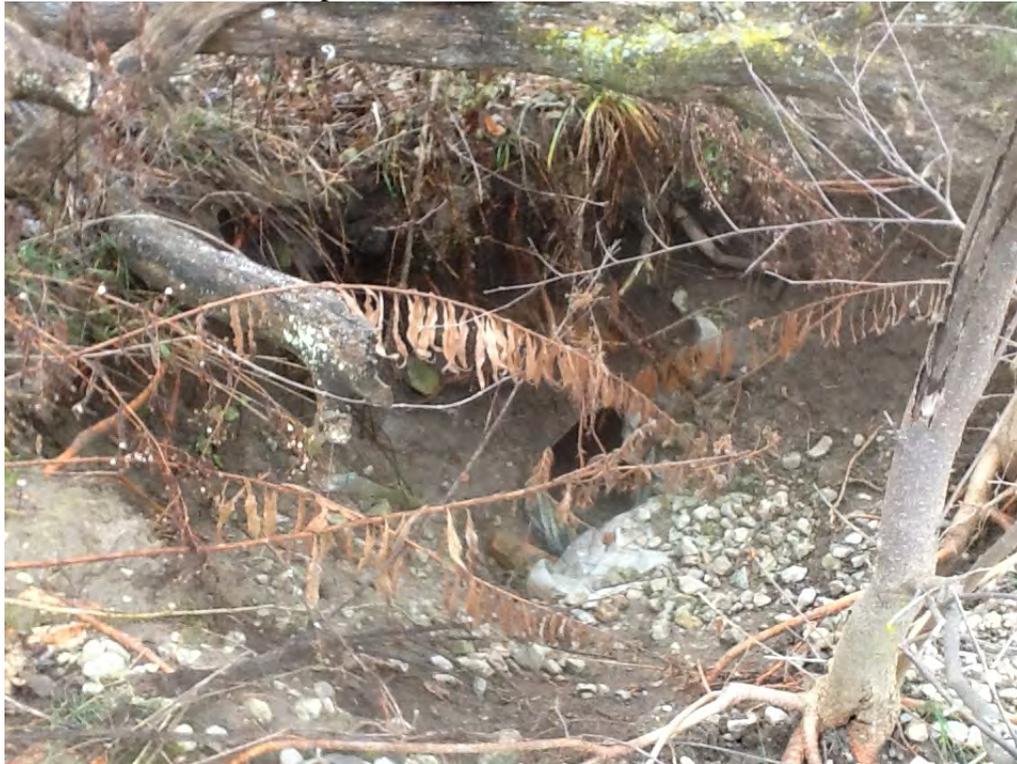
Photo #28 – Tile sedimentation just downstream of structure 101.

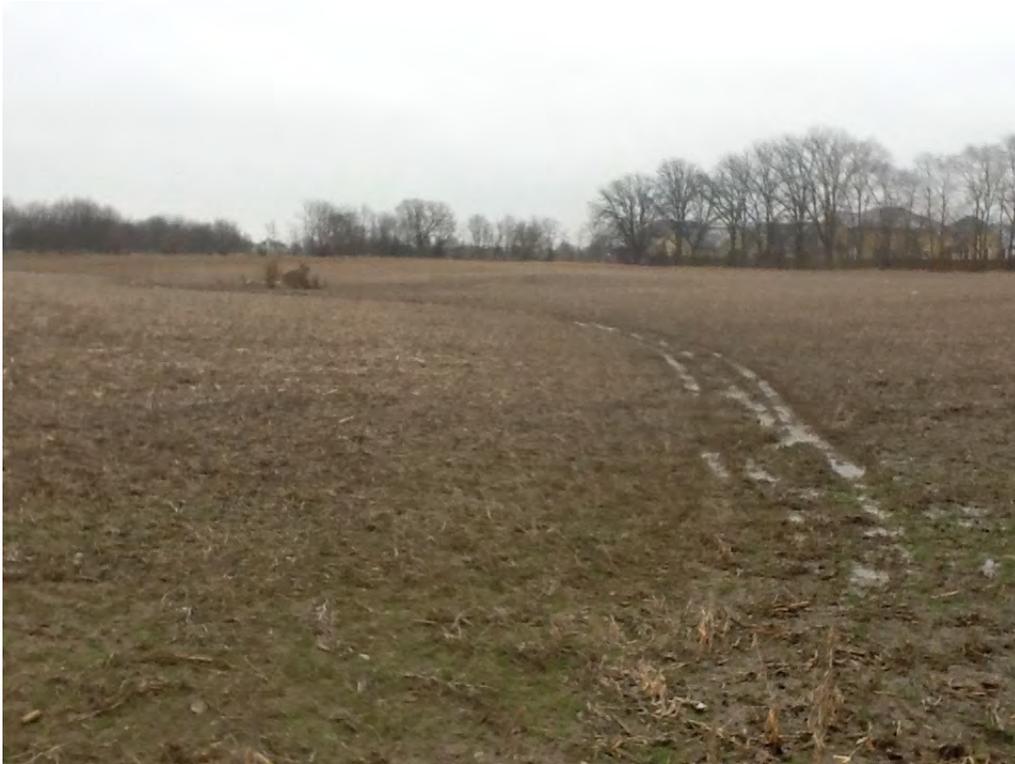
Photo #29 – Looking downstream from structure 101.
