Prepared for:

Cooperstown Partners, LLC.
Attn: Jim Adams
836 East 64th Street
Indianapolis, IN 46220

Submitted to:
Hamilton County Drainage Board
Attn: Kenton C. Ward
One Hamilton County Square, Suite 188
Noblesville, IN 46060

February 26, 2014

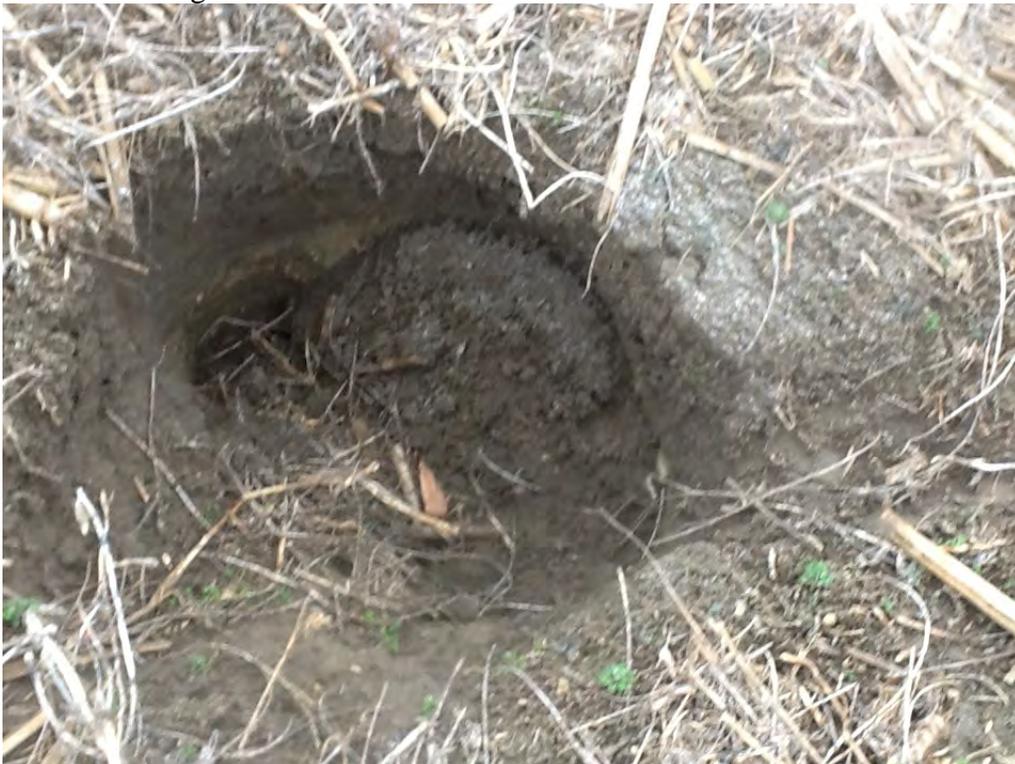
Photo #30 – Tile blow hole in middle of Heritage Baptist Church property.

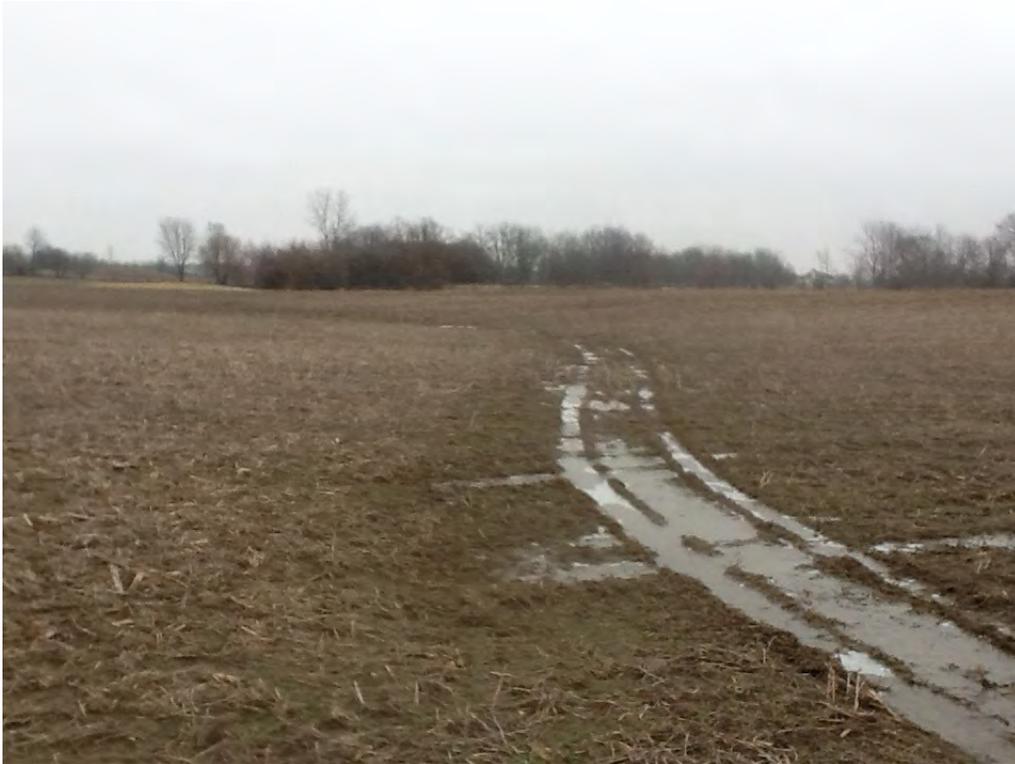
Photo #31 – Looking east in middle of Heritage Baptist Church property.

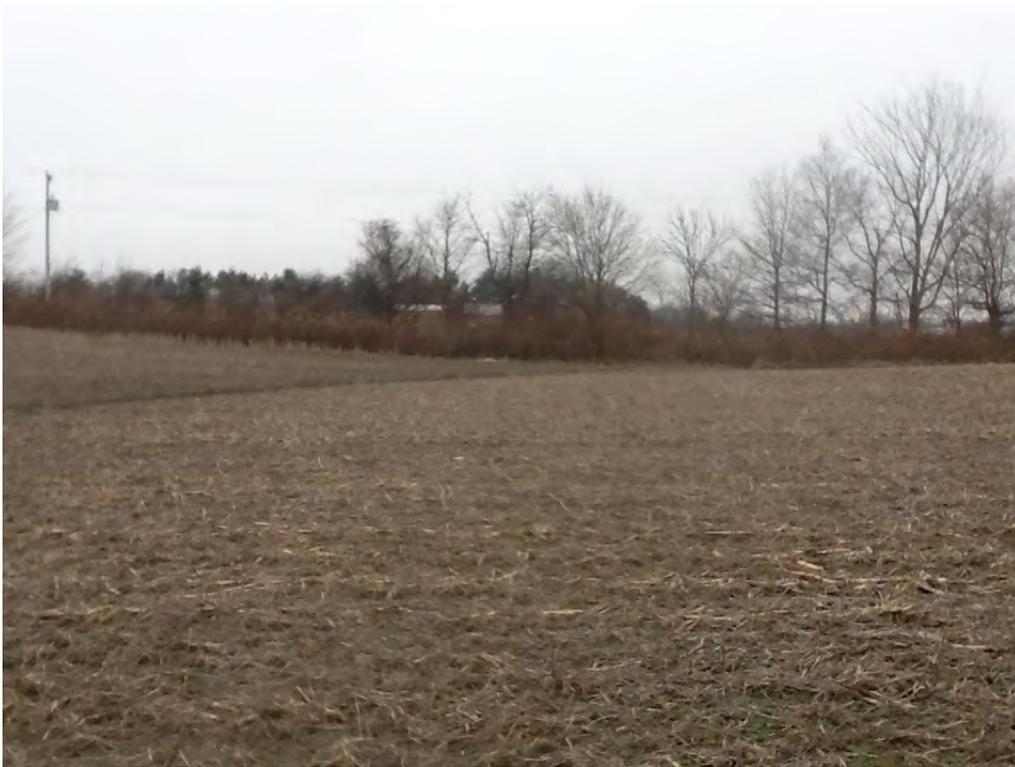
Photo #32 – Looking west in middle of Heritage Baptist Church property

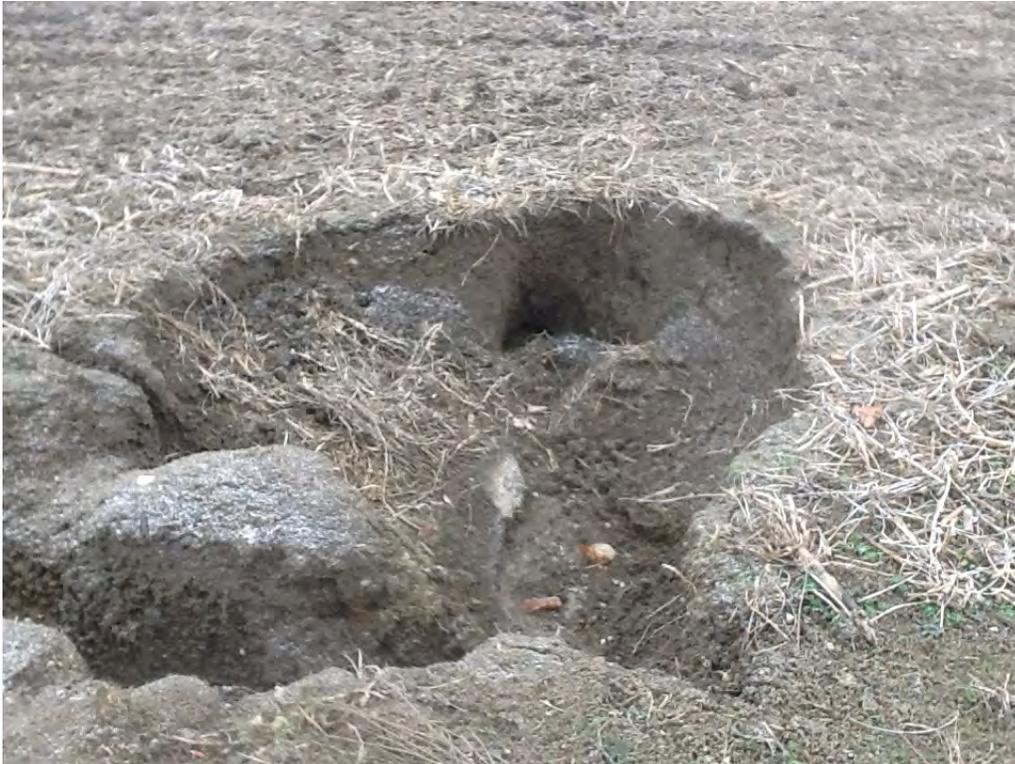
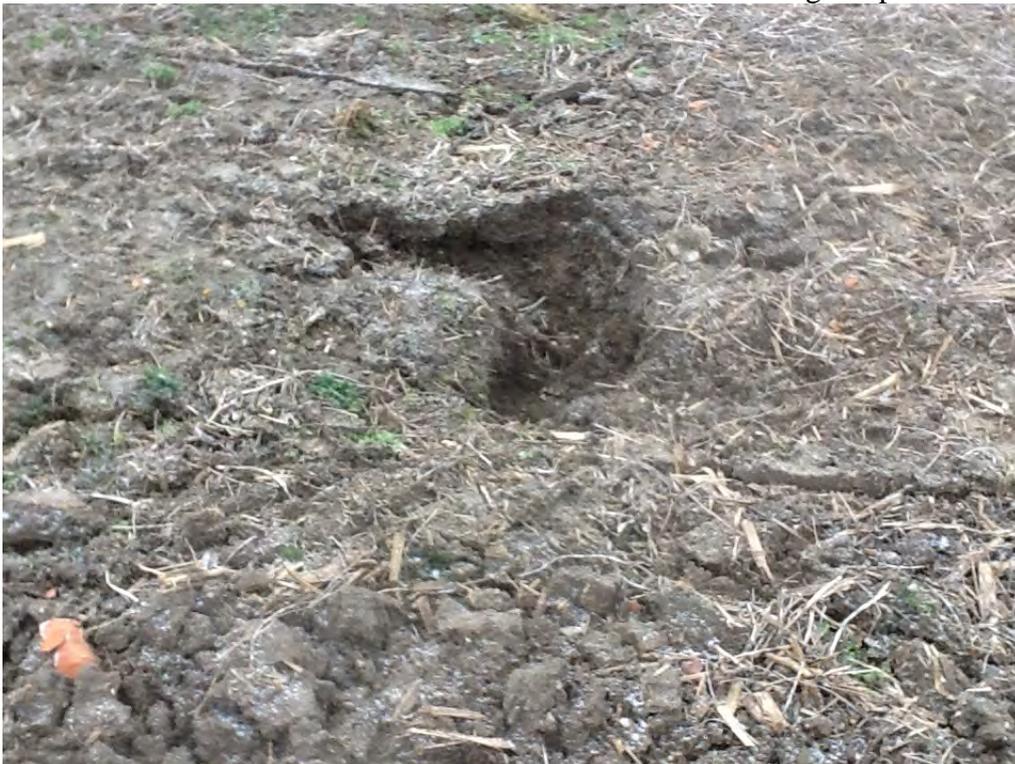
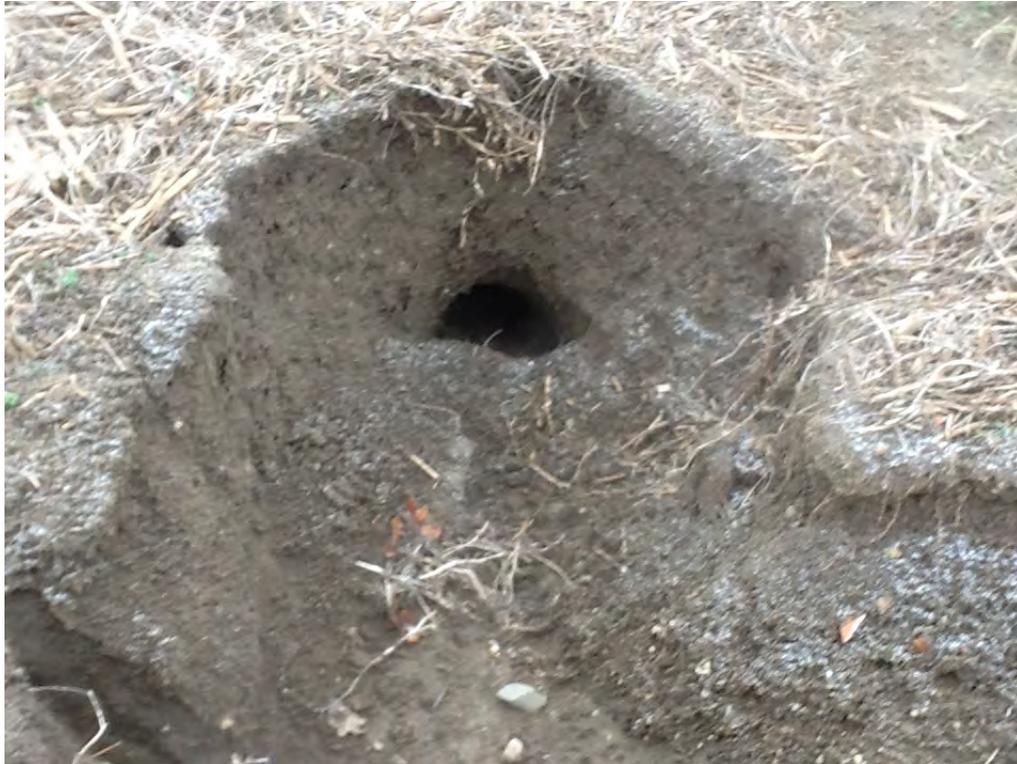
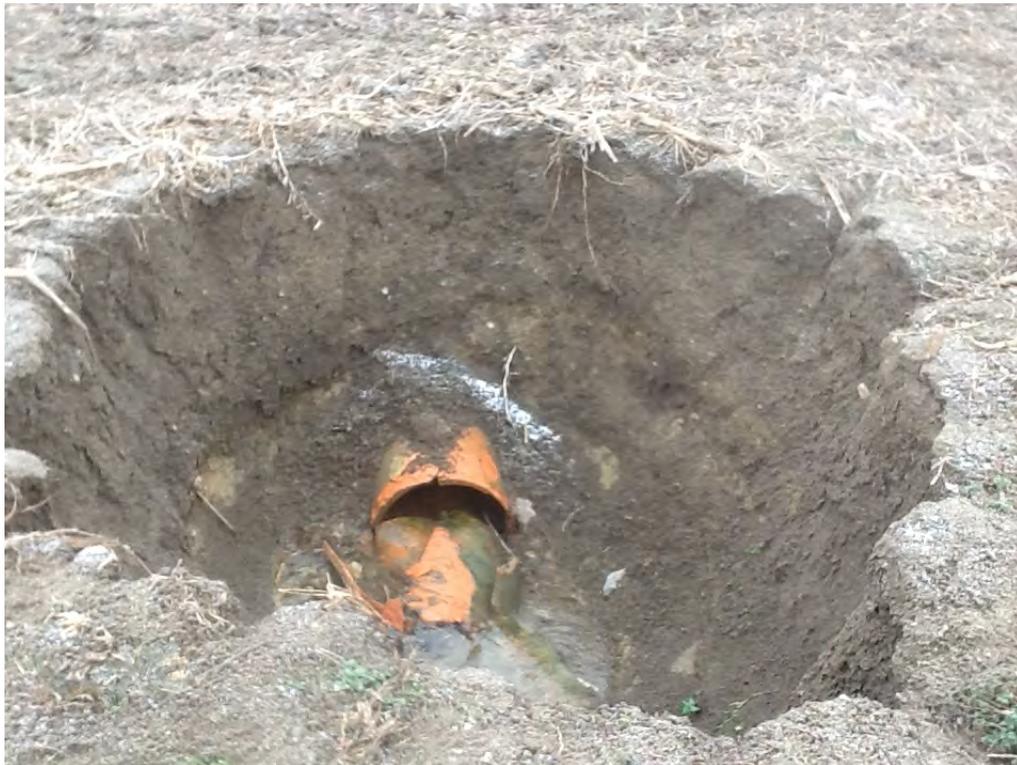
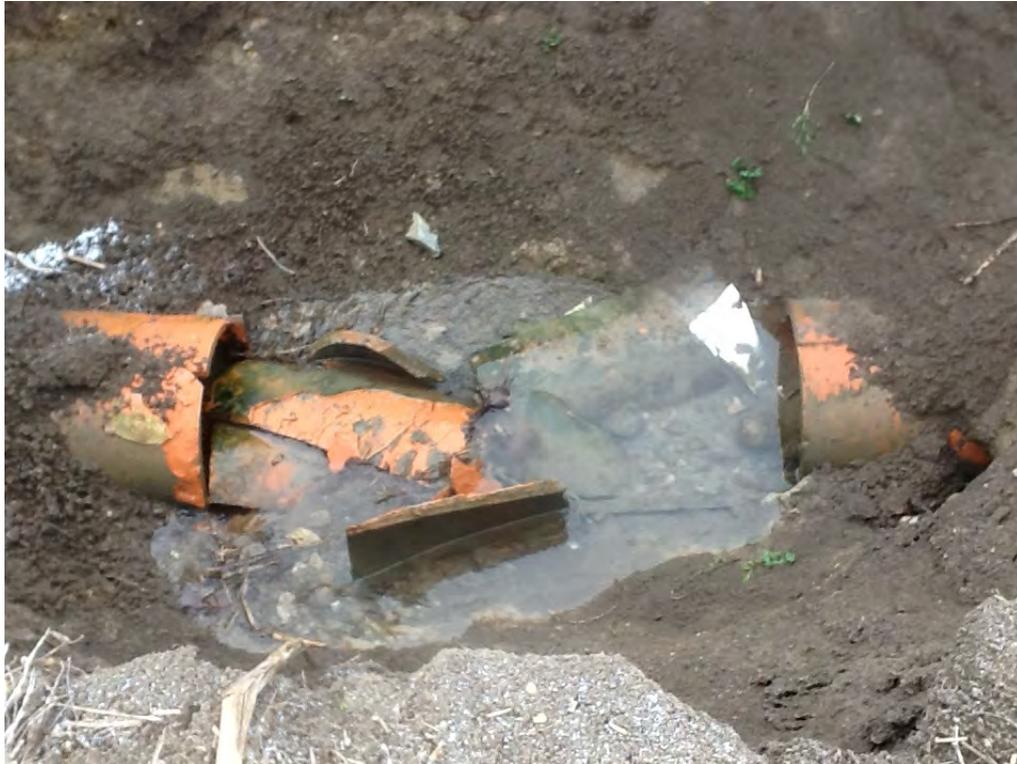
Photo #33 – One of the numerous tile holes on the eastern half of the Heritage Baptist Church property.

Photo #34 – One of the numerous tile holes on the eastern half of the Heritage Baptist Church property.

Photo #35 – One of the numerous tile holes on the eastern half of the Heritage Baptist Church property.

Photo #36 – One of the numerous tile holes on the eastern half of the Heritage Baptist Church property.

Photo #37 – One of the numerous tile holes on the eastern half of the Heritage Baptist Church property.

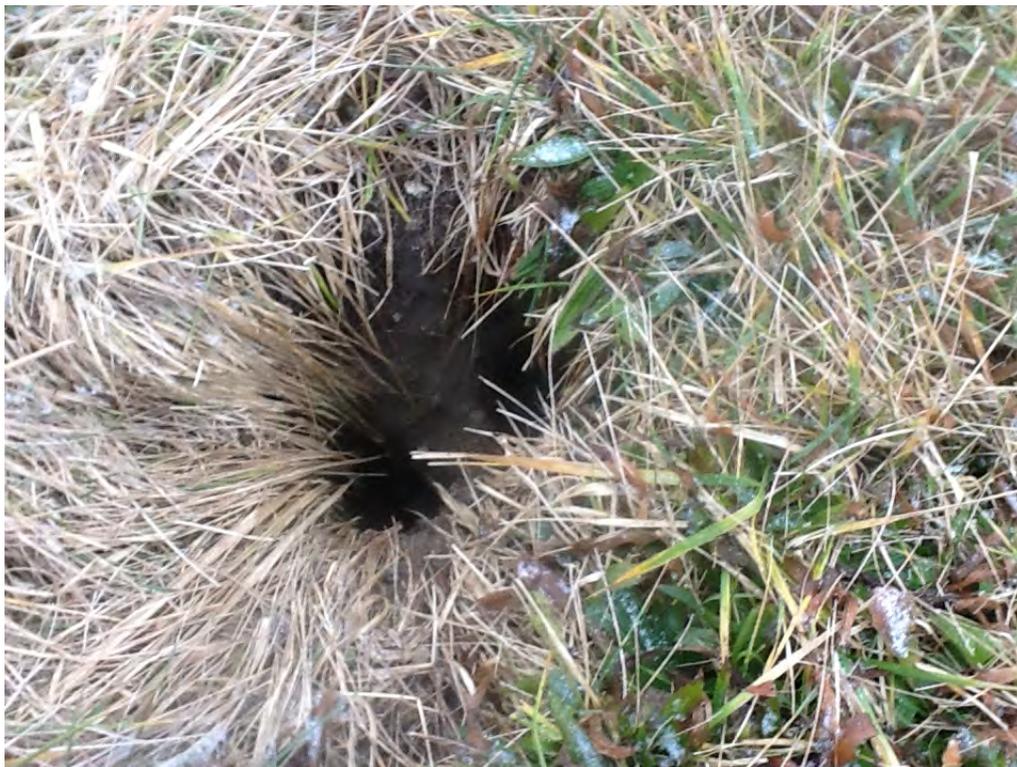
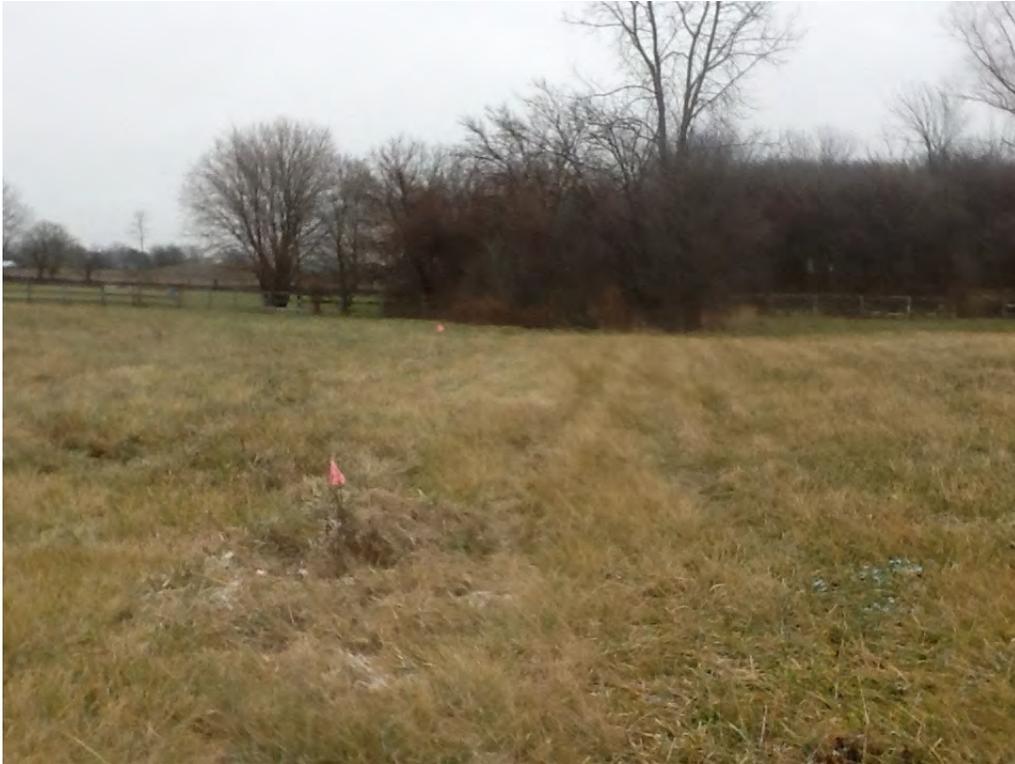
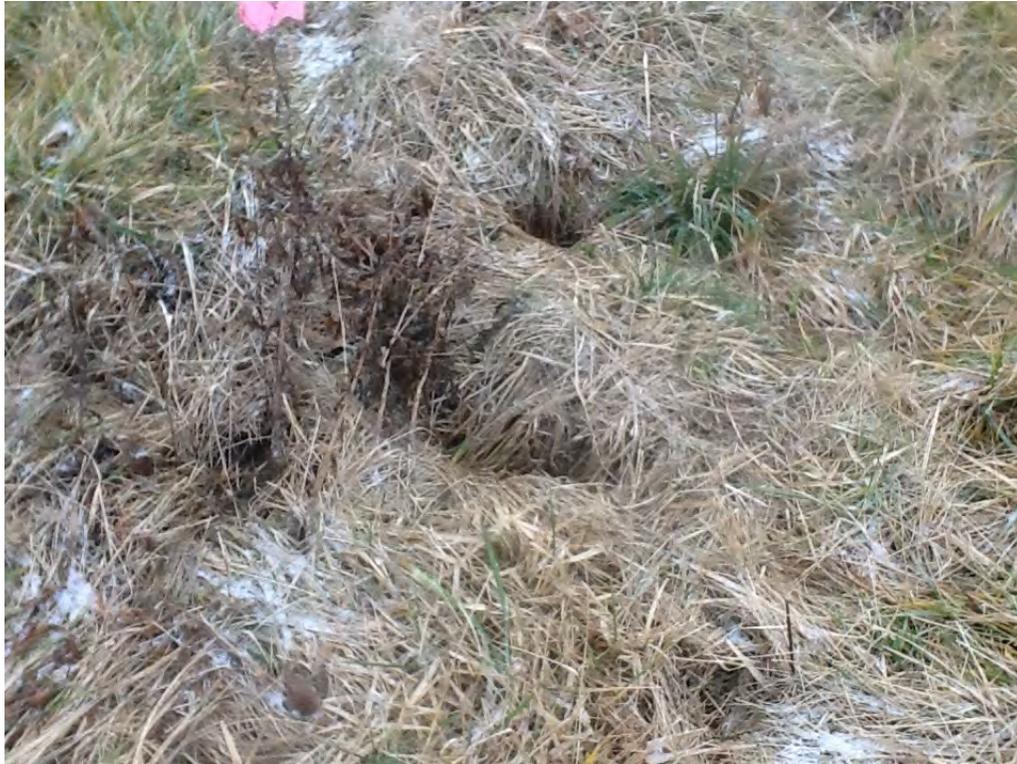
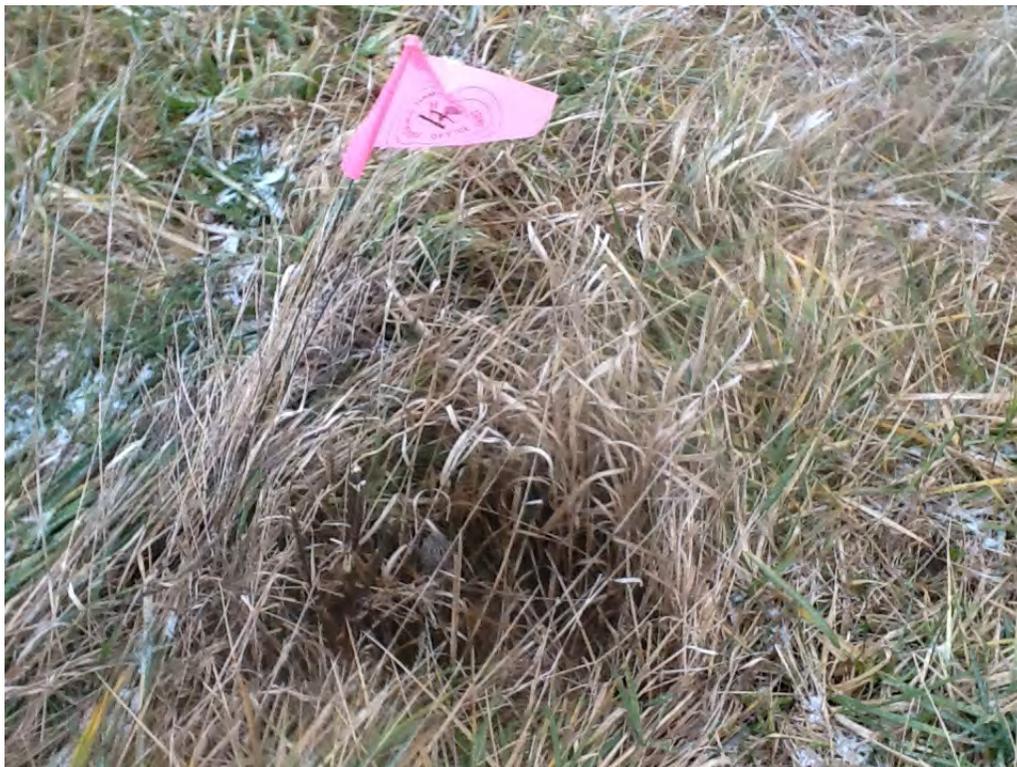
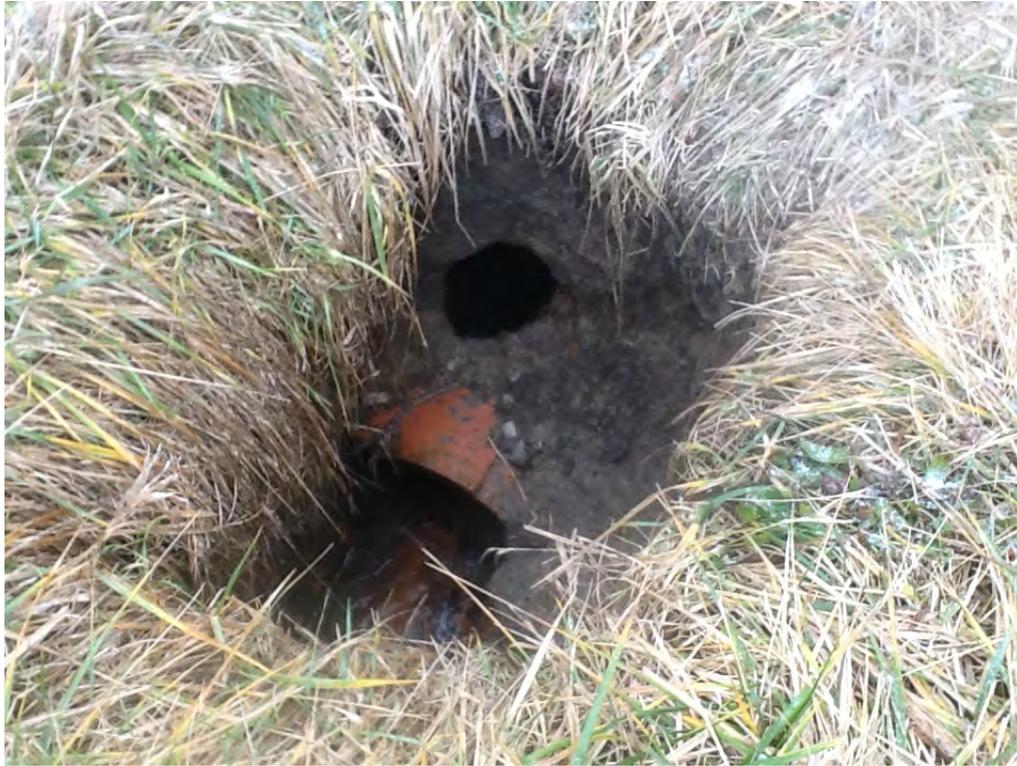
Photo #38 – One of the numerous tile holes on Klingensmith property.

Photo #39 – One of the numerous tile holes on Klingensmith property.

Photo #41 – One of the numerous tile holes on Klingensmith property.

Photo #42 – One of the numerous tile holes on Klingensmith property.

Photo #43 – One of the numerous tile holes on Klingensmith property.

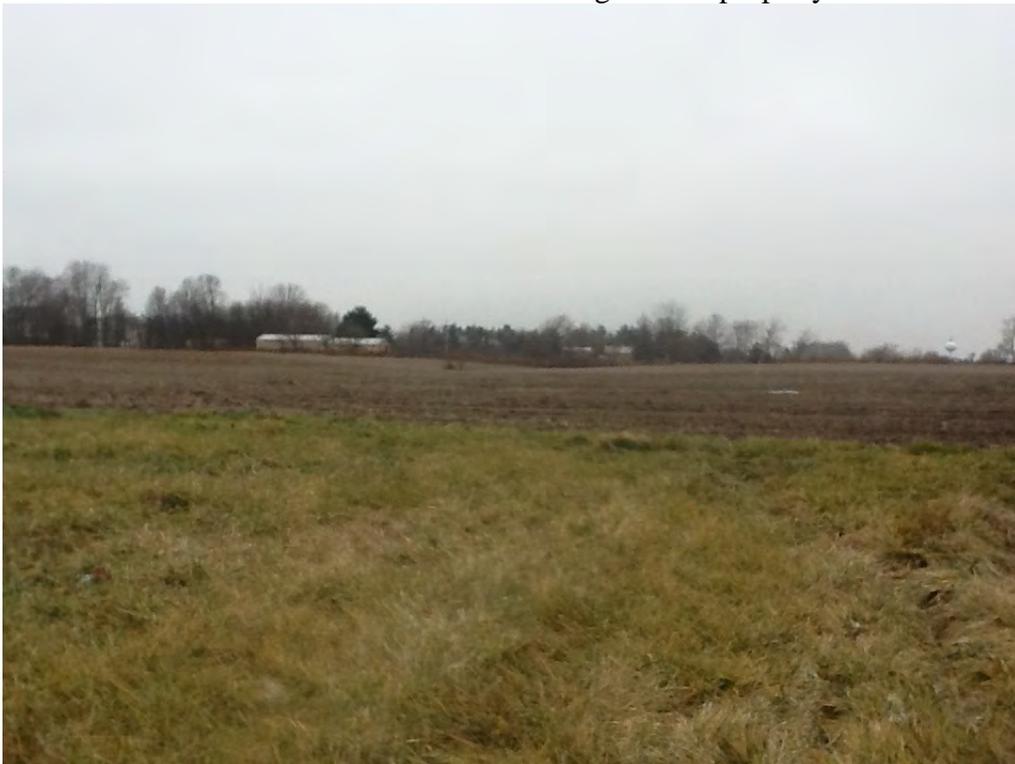
Photo #40 – Looking west from Klingensmith property.

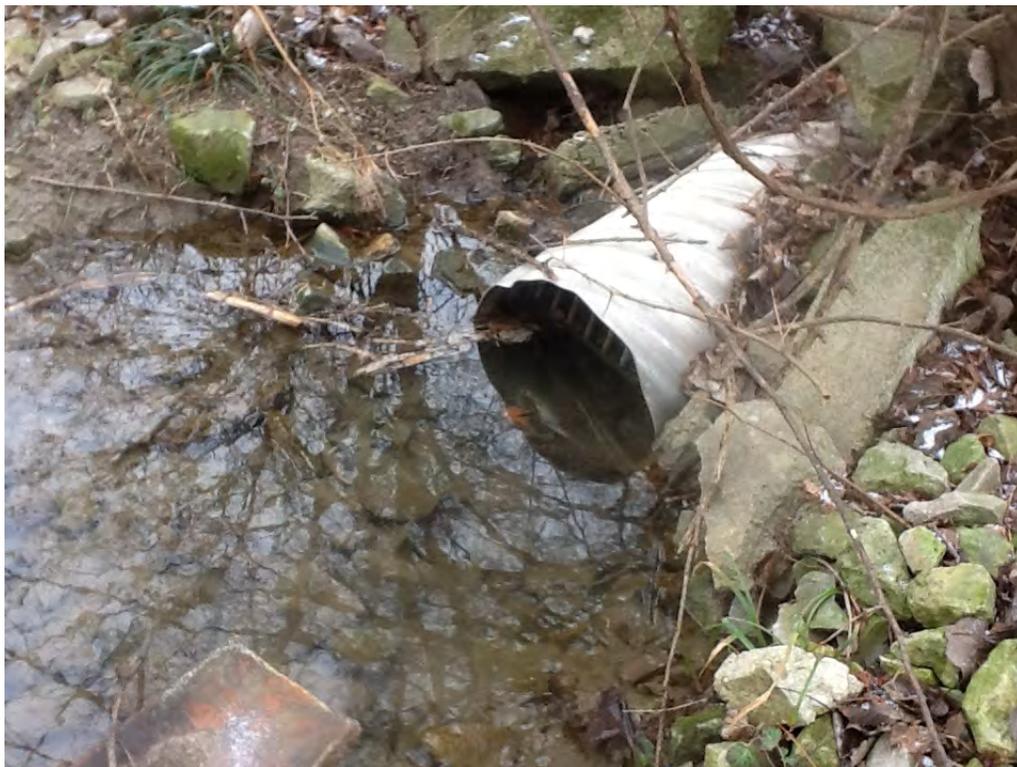
Photo #44 – Current tile outlet, notice submerged.

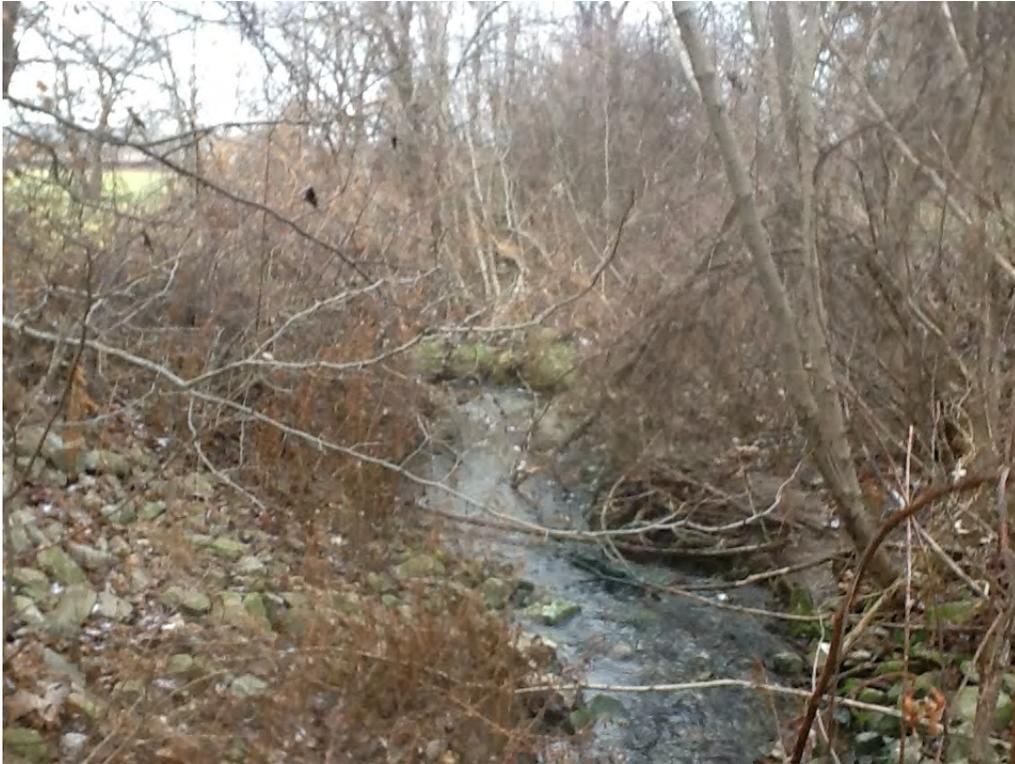
Photo #45 – Looking downstream of tile outlet.

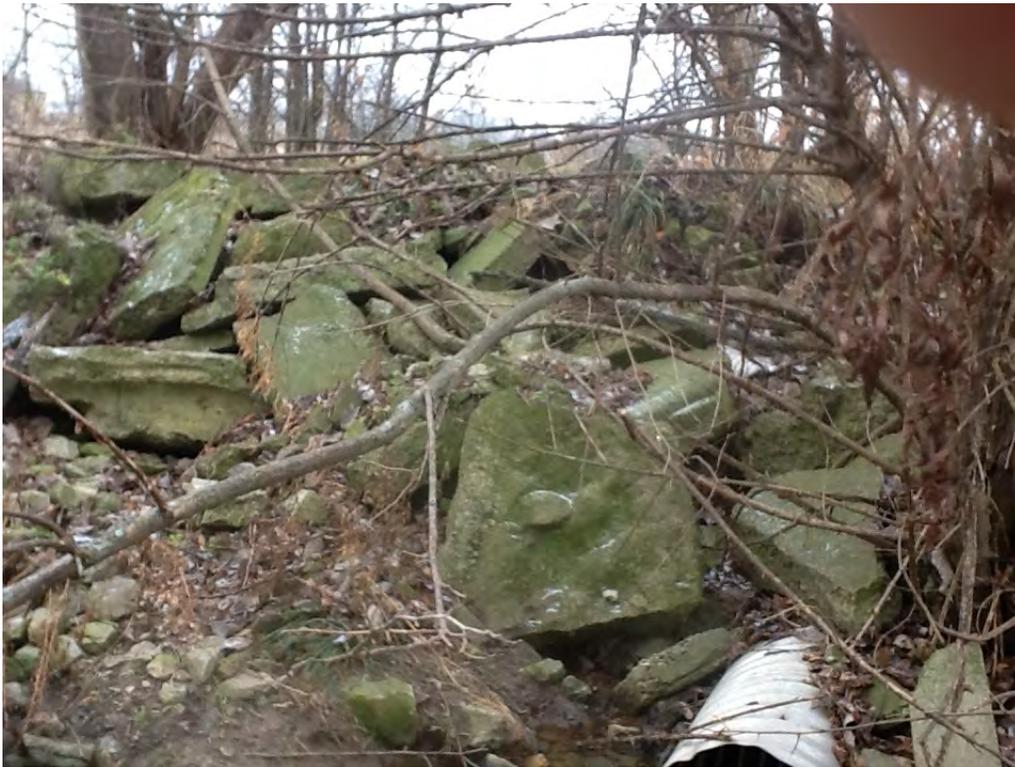
Photo #46 – Concrete rubble tile on Klingensmith property.
